**SUBJECT: Hazardous Materials Inspection  
Moultrie Courthouse, Fourth Floor**

Maxximus Environmental, Inc. has completed a hazardous materials survey of selected portions of the fourth floor of the Moultrie Courthouse. The survey included an asbestos inspection, a lead-based paint inspection, and a survey for universal wastes.

**SUBJECT: Asbestos Inspection  
Moultrie Courthouse  
Fourth Floor**

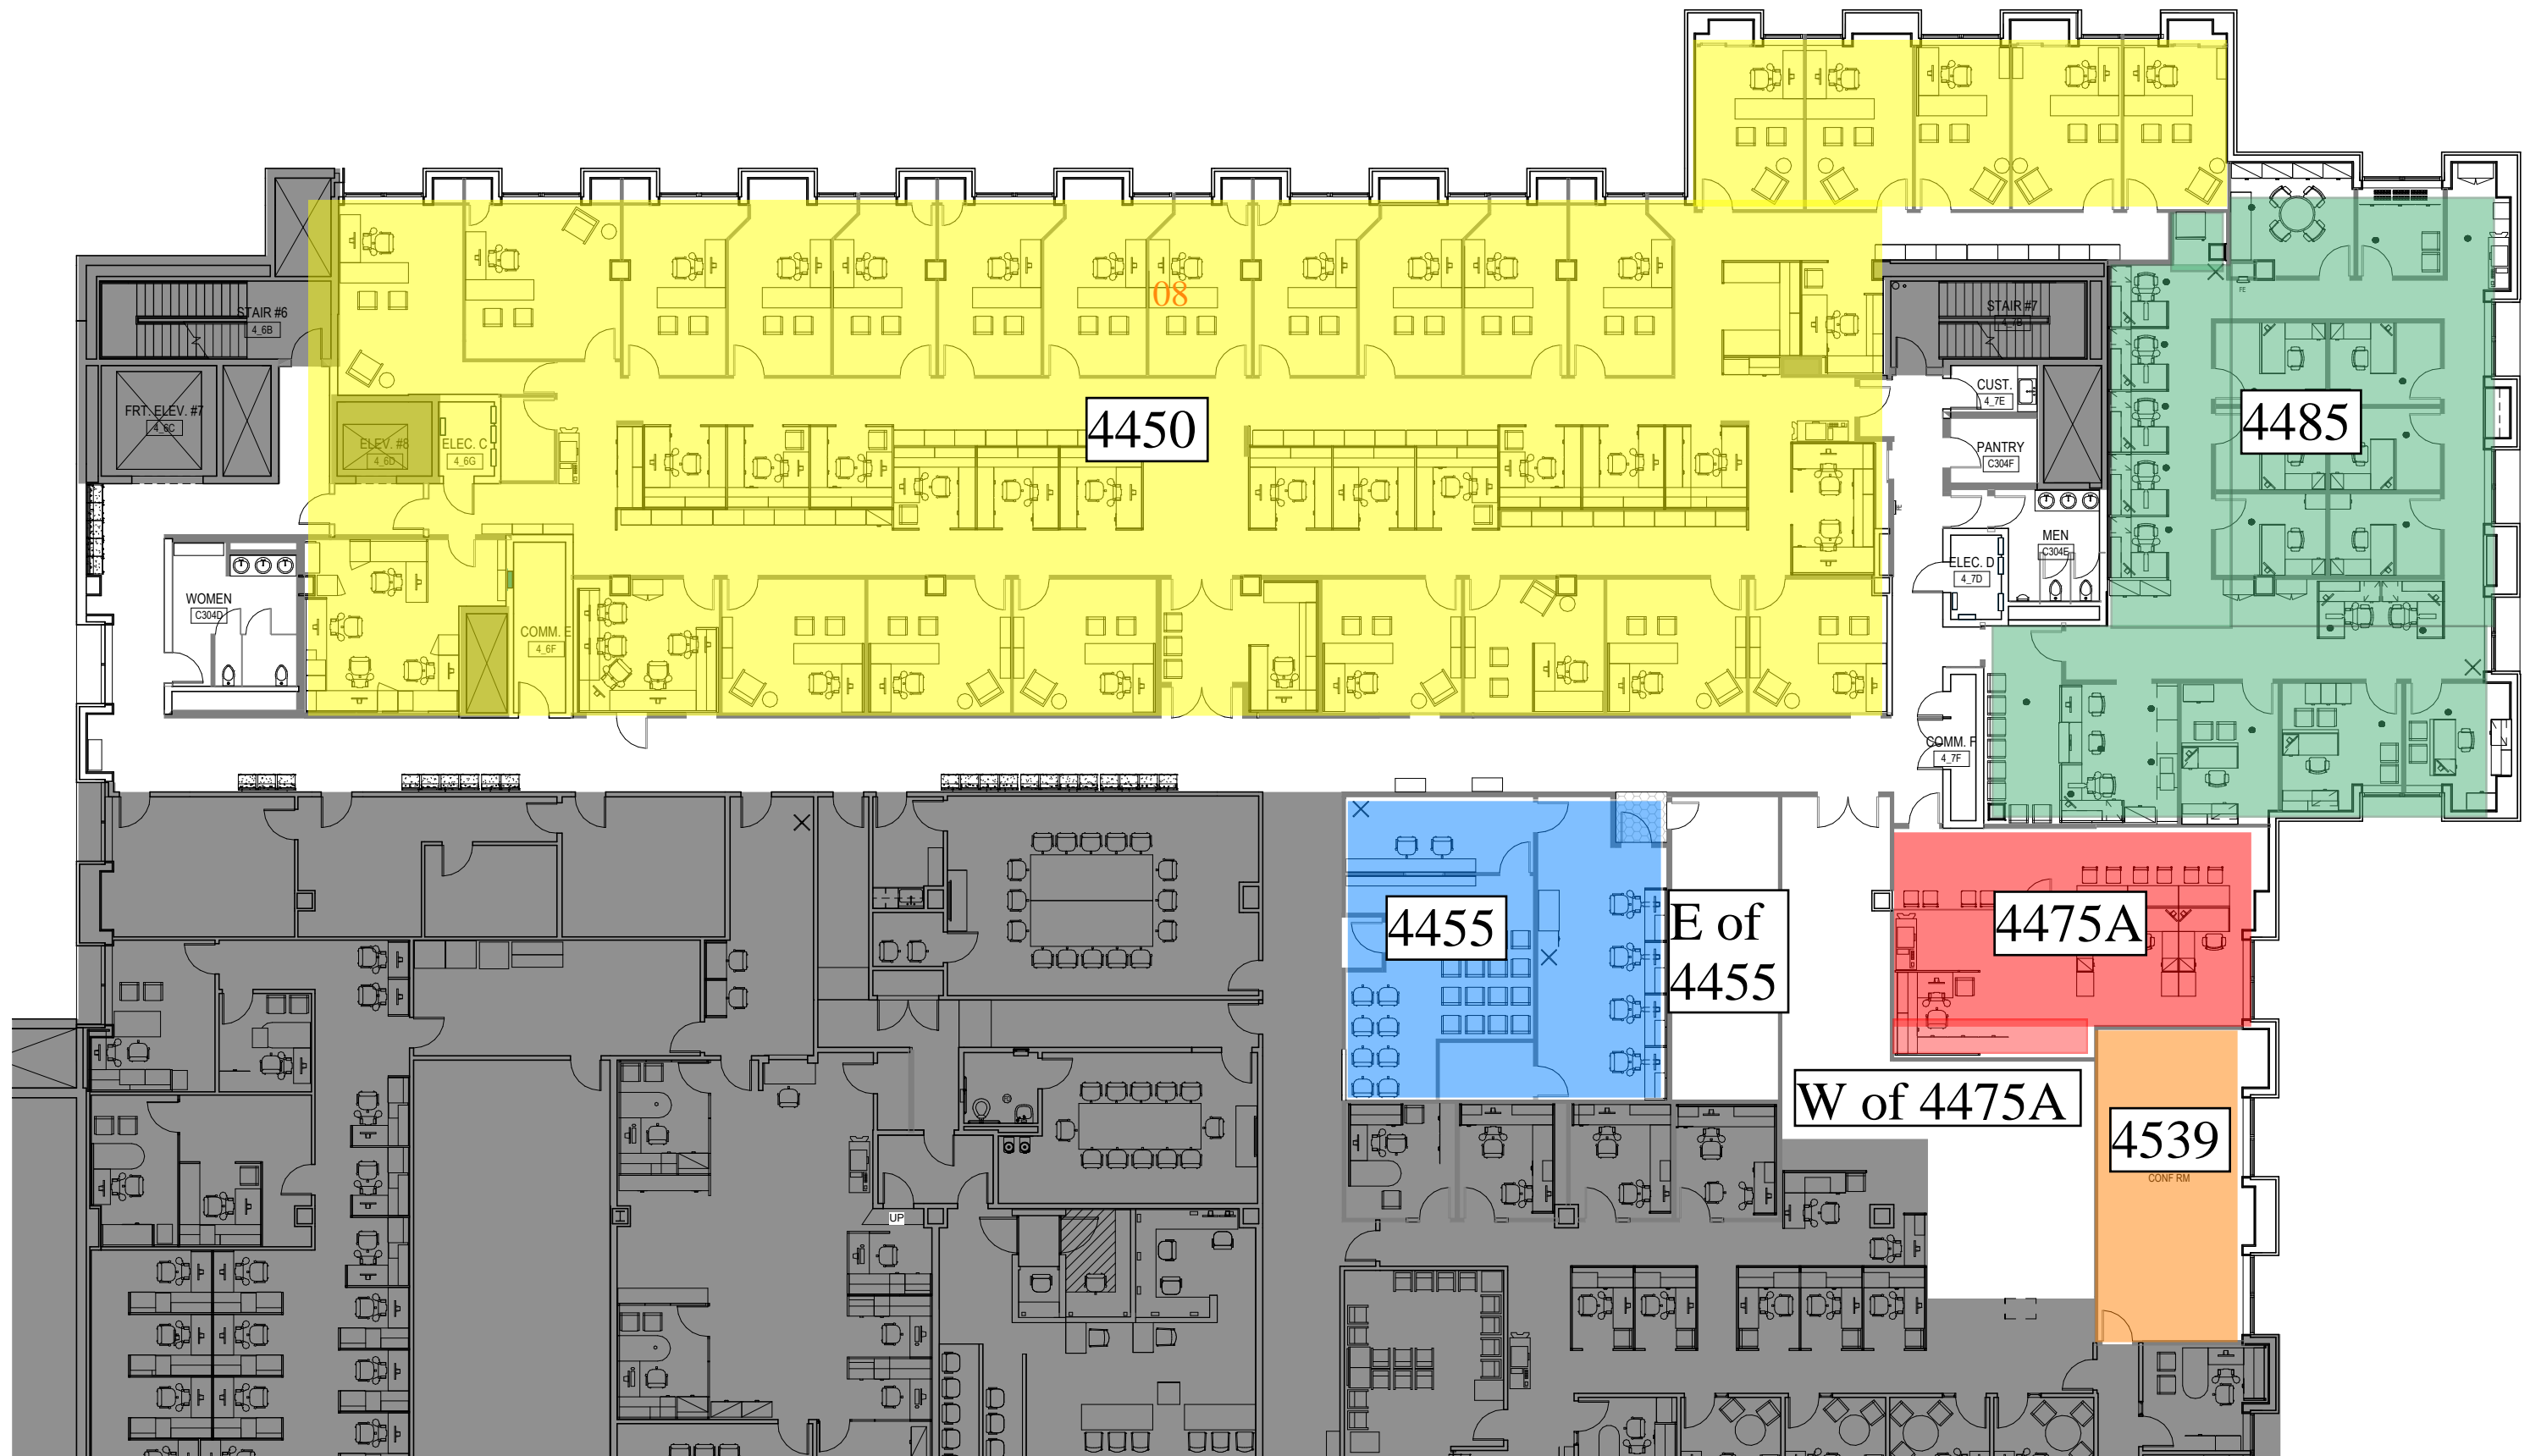
Figure 1 - Suite Numbers in Asbestos Report

The first attached sketch provides a reference for suite numbers as used in this report.

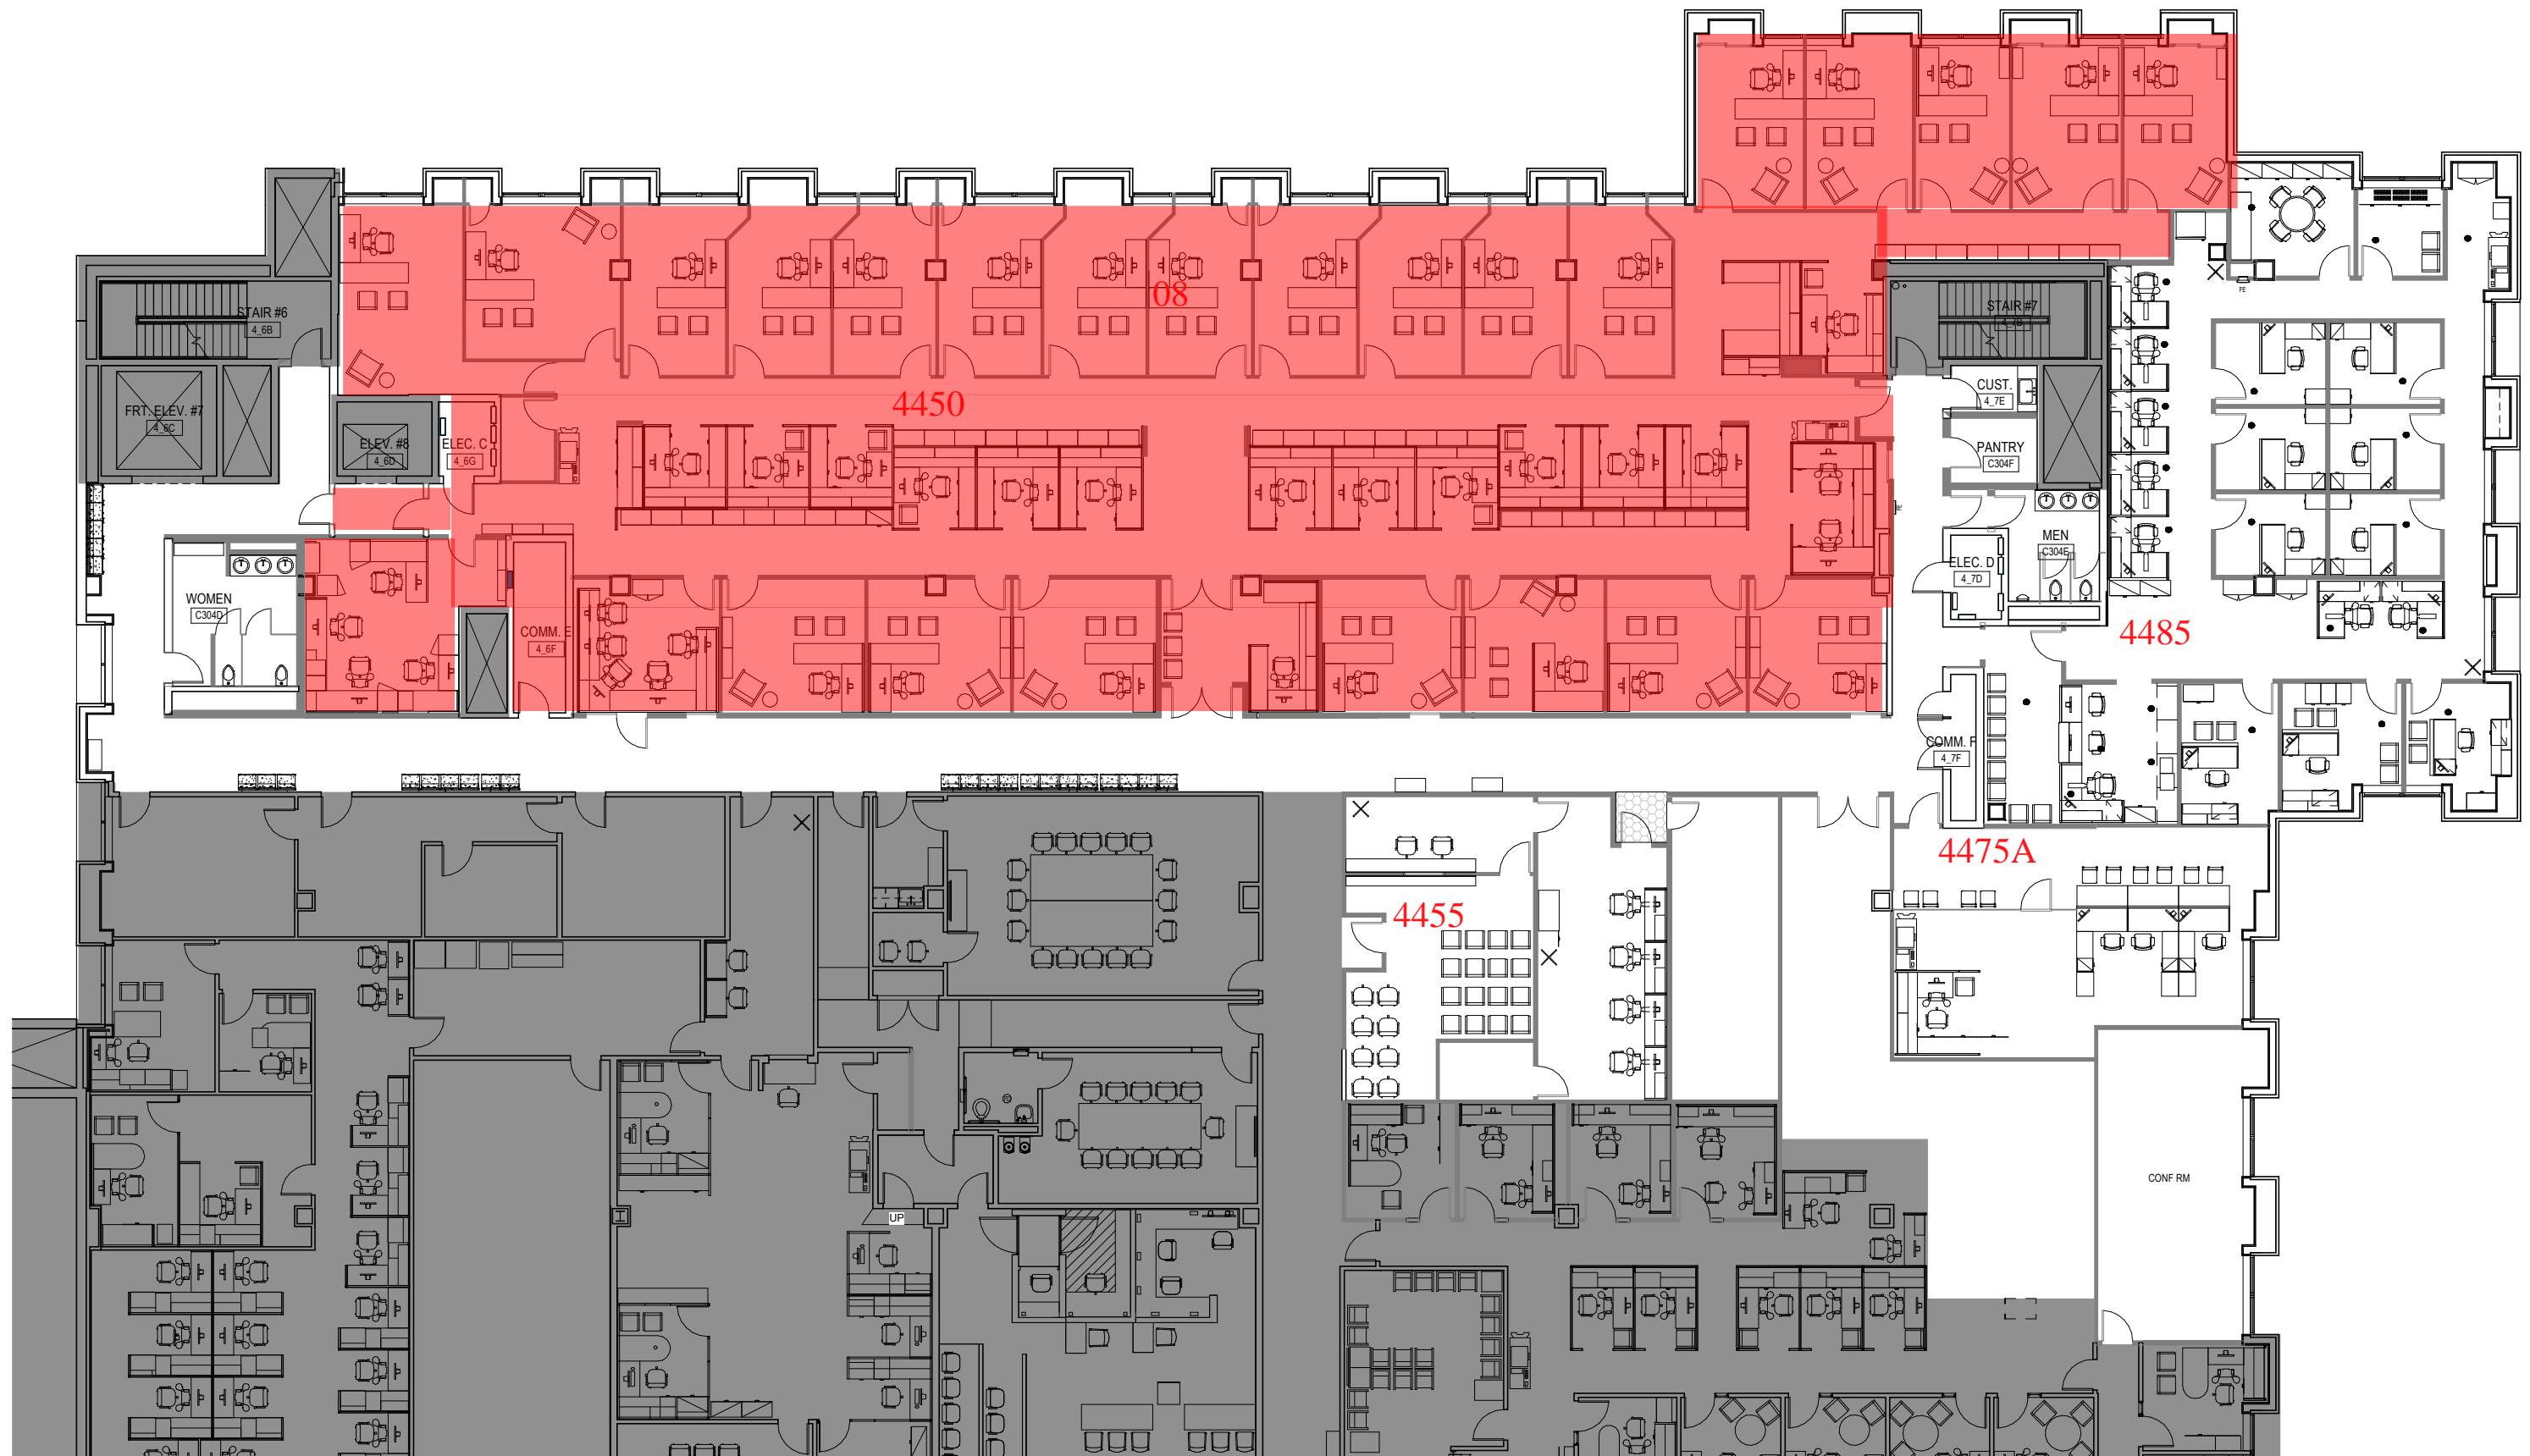
Figure 2 - Locations with ACM Floor Tile (Red highlight)

Floor tile was observed under the carpet throughout suite 4450. In the pantry, there is about 60 square feet of a top layer of tile and a bottom layer of tile. The bottom layer in the pantry was negative in the one sample collected. Because of the hidden nature of this lower layer, it will be difficult to do a good job of collecting confirmatory samples. Because of the small amount of this material, it is recommended to remove it as asbestos along with the floor tile in the rest of suite 4450.

1. Remove asbestos containing materials that will be impacted by construction following all state and federal regulations.
2. Two additional joint compound samples are recommended in each suite with a negative result. Joint compound in each suite can then be treated independently. The alternative is to consider all joint compound positive.
3. Asbestos containing materials that will not be impacted by construction can be managed in place or removed as you prefer.

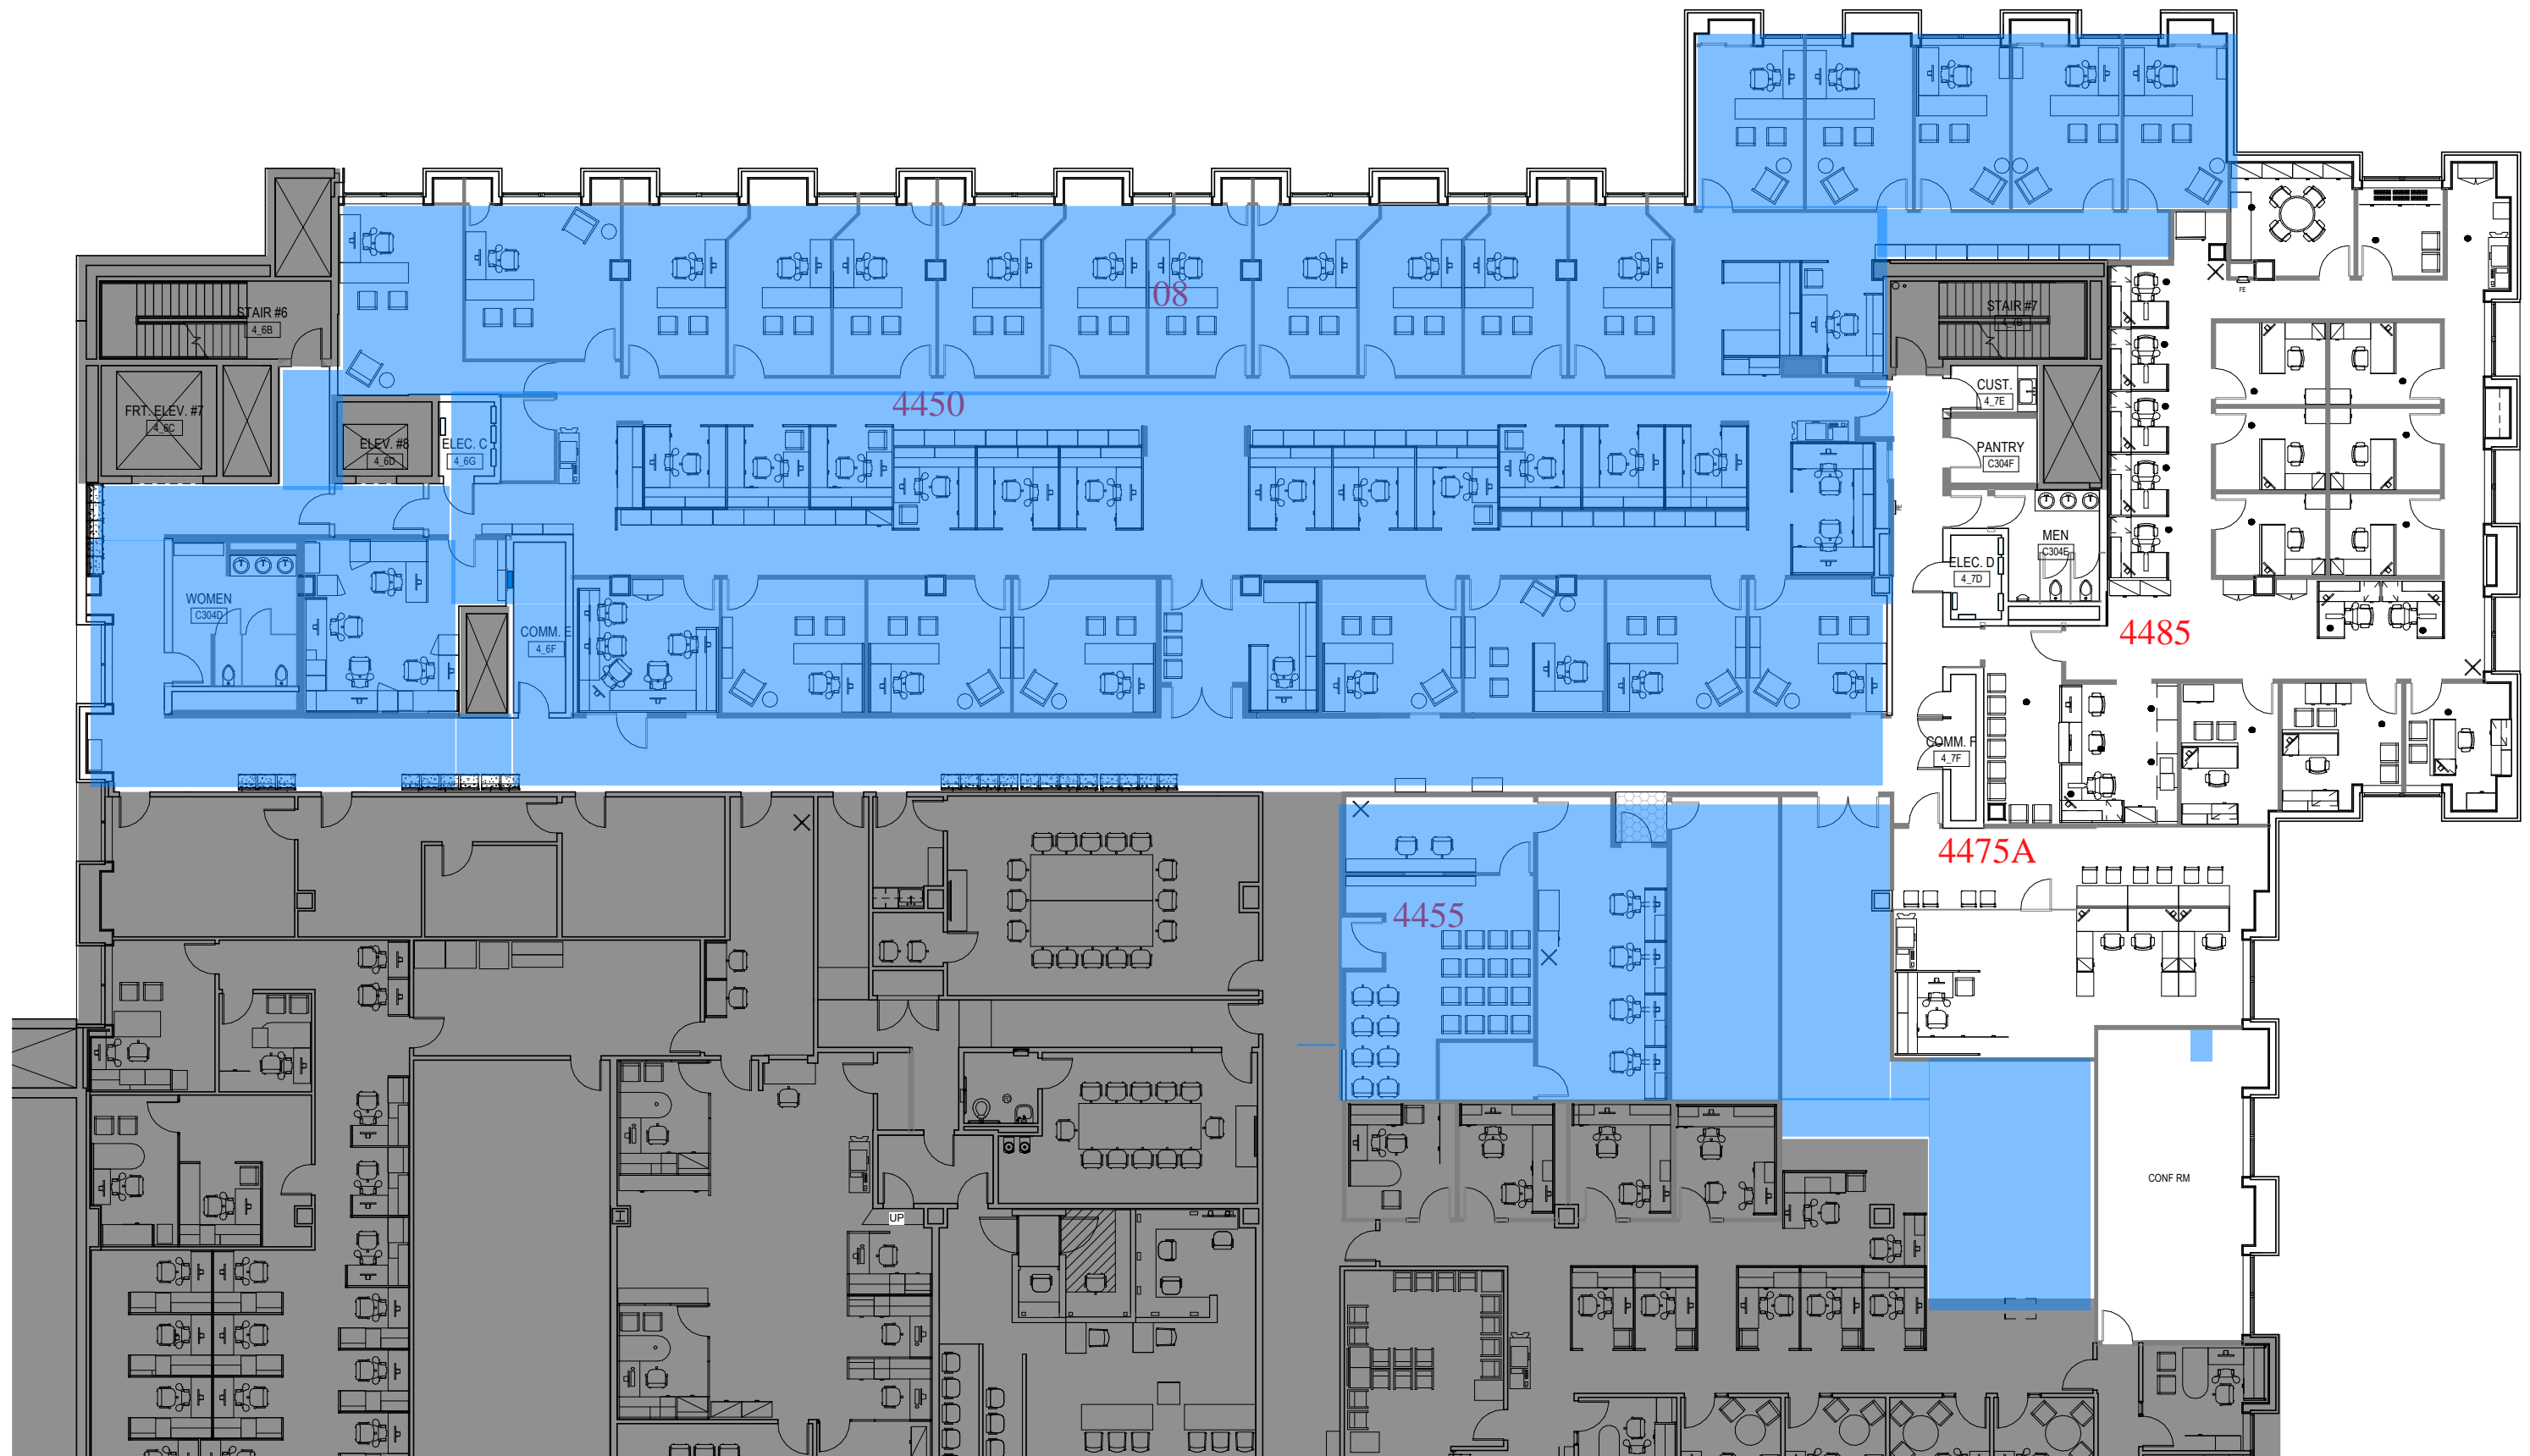
Figure 3 - Locations with ACM Duct Seam Sealant (Blue highlight)

Red duct seam sealant was observed in 4450, the hallway south of 4450, east of 4455, and 4539. In 4539 it is a 1 foot length of duct extending in from 4475A. Remaining ductwork is new and has gray seam sealant. Sample 5016 represents the negative seam sealant.

Duct insulation in the area where the metal ducts have red seam sealant has white seam sealant on the fiberglass. The white seam sealant contains asbestos.

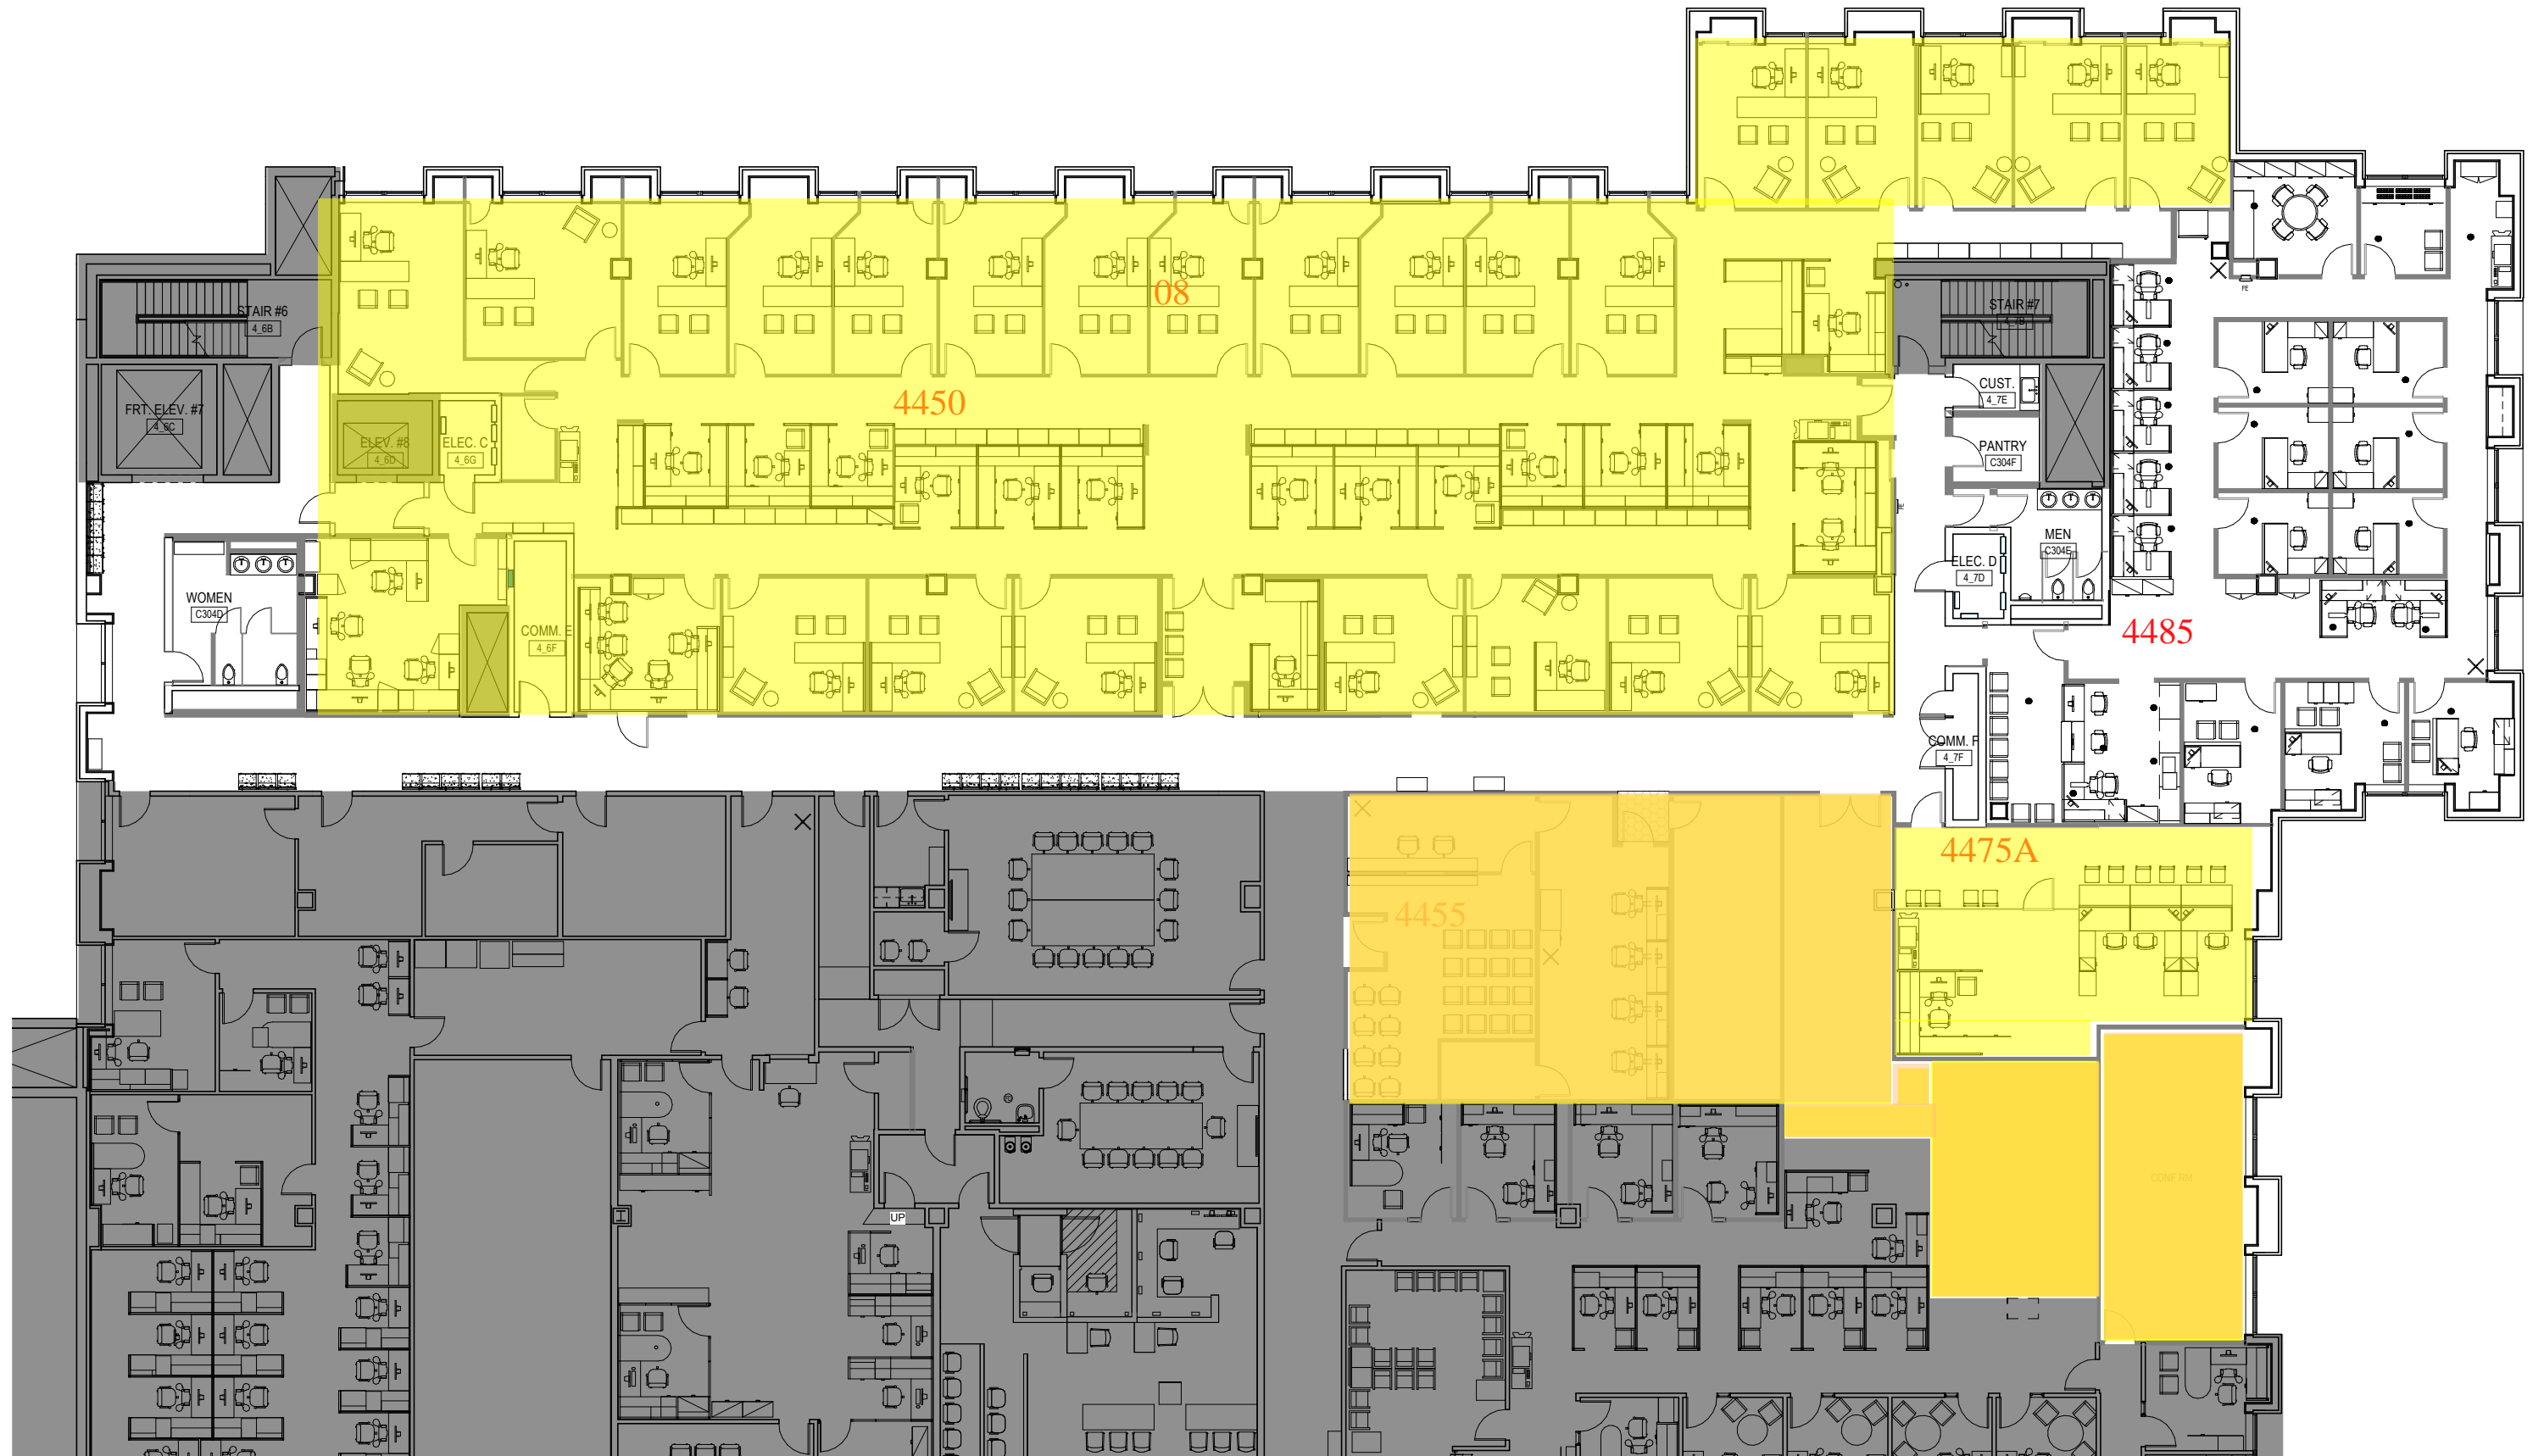
Figure 4 - Locations with ACM Joint Compound (Yellow highlight)

Joint compound is positive in some samples and negative in some samples. Figure 4 depicts areas where samples were positive with a yellow highlight. Areas where samples were negative are either white or orange. White areas were reported by DC Courts to have all new sheetrock at the time of the last renovation. Orange areas have been renovated by were reported by DC Courts to possible have some original walls in place. Walls in orange areas are to be handled as ACM except that the contractor may elect to collect two samples from each wall to document on a wall by wall basis if the joint compound contains asbestos.
