District of Columbia Courts

BUILDING ASSESSMENT REPORT

PRELIMINARY REPORT (BUILDING B ONLY)

510 4th Street, NW

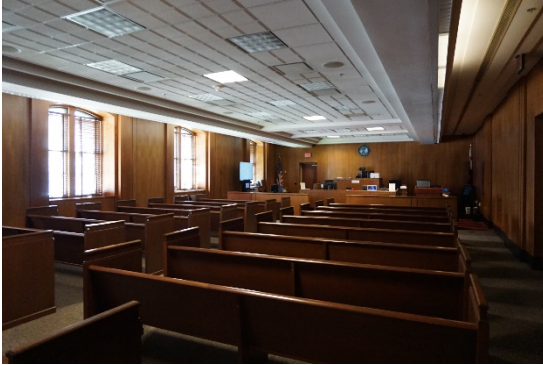
Areas with historic finishes, such as courtrooms, lobbies and main corridors require repair due to normal wear and tear and time. Major sections of marble slabs need to be repaired or replaced due to discolored or cracked slabs and failing mortar joints. Wood panels that are faded or cracked need to be refinished or replaced.

Wood Paneling and Seating at Courtroom

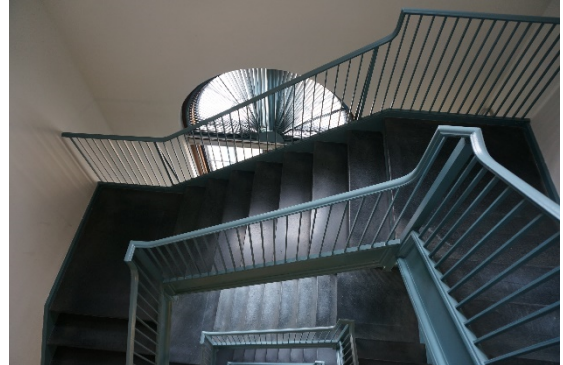
Central Stair from Ground to Third Floor

More specifically, all (3) public stairs require guardrails on both sides that are a minimum 42" high. The existing handrails do not extend 12" from the bottom tread, as required by code, but are within the 30-42-inch height. And the historic glazed metal frame doors at the ground level main entrances do not adhere to the minimum width required for egress.

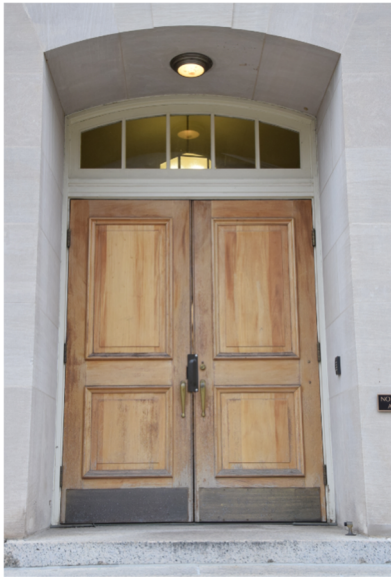
The main entrance for Building B is located at the East Elevation and consists of three pairs of solid wood exterior doors located in the center of the façade. The North, South, and West elevations have a set of double solid wood doors per elevation that are used mainly to exit the building. All Doors include historical custom wood frames and associated hardware. All exterior doors are fully operational and in good standing. The main deficiency is aesthetically where the wood doors and frames need to be cleaned, re-stained, and refinished. There are some areas around the door frame where the joint sealant needs to be replaced due to weathering.

Exterior Door at South Elevation

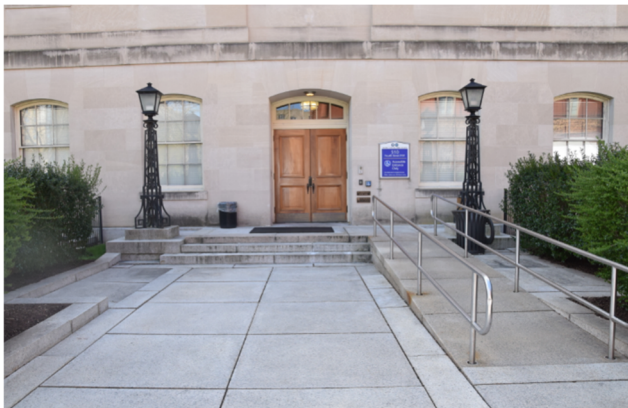
Building B has a ramp for accessibility located at the north elevation. The ramp railing needs to be upgraded due to the missing of the edge protection rail. At this time the ramp is not code compliant and the granite flooring slabs have to be re-leveled. In addition, each access to the building is flanked with a pair of historical cast iron light posts mounted on a granite base. These historical light posts are structurally in good condition. However, there are signs of rust on the cast iron. The corrective recommendation is to scrape and refinish all light posts.

North Elevation Accessible Ramp

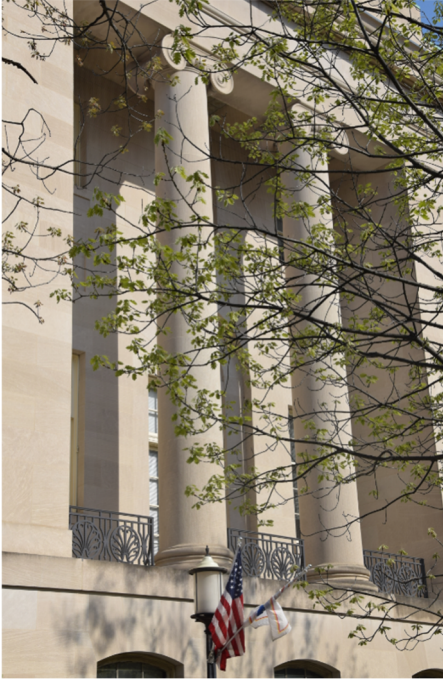
The main deficiencies on the balconies are the historical cast-iron railings that have to be upgraded to a 42" minimum height and the space between the columns and the railing should not exceed a 4" sphere diameter to meet code. Otherwise, the balconies are in good condition and only require to be power washed in the next three to five years.

West Elevation Balconies

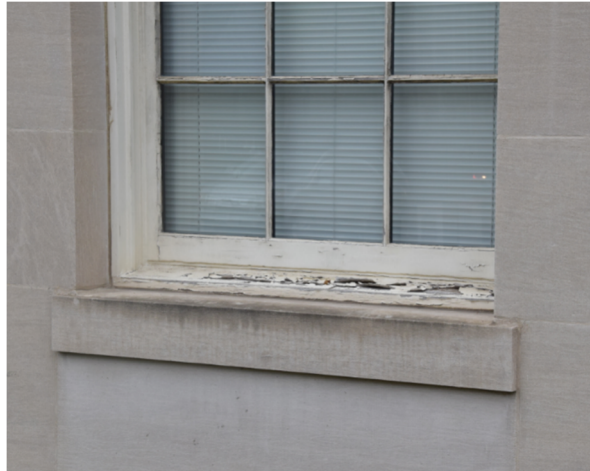
All building elevations include historical custom wood framed double-hung windows with insulated glass and an extra layer of glazing in the interior which was installed in recent years for extra thermal performance. All windows throughout the building are fixed. The main deficiency noticed at the windows is the condition of the wood frames, especially the window wood sills. The window wood frames seem to have deteriorated and are in critical condition due to weathering. The Architecture building enclosure team recommends repair and refinish all window framing and replace as needed, beginning at the south elevation which is in the most critical condition. All window exterior glazing must be cleaned due to the presence of dust and debris.

Wood Trim and Sill Condition at South Elevation

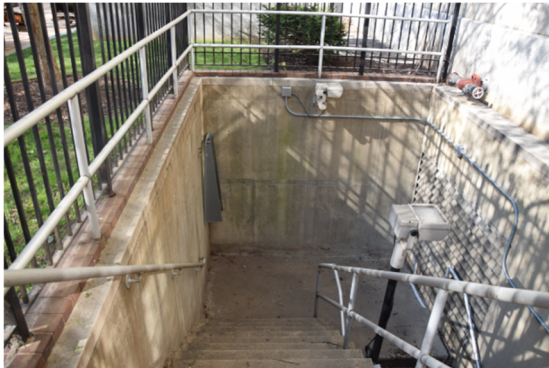
The building has four underground exterior stairs for basement access, two at the East and two at the West grounds. These entrances are secured with black painted cast iron gates at the ground level around the stairs. Each entrance includes painted hollow metal doors to enter the building at the basement level. The general deficiency for these areas is the presence of waste and debris from the surroundings and environment. Repainting the walls and doors seems to be past overdue. The main recommendation for these areas is to clean and repaint.

Basement Service Entrance at West Grounds

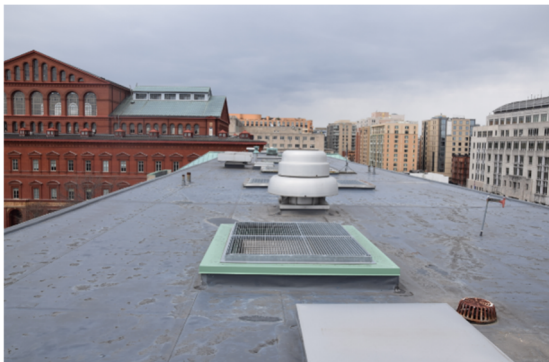
The building roof consists of a sloped copper standing seam roof system, adjacent to the central core of the roof. The low slope roof covering is made of a single-ply PVC roofing with heat-welded, fully adhered membrane with rigid roof insulation supported by the structural roof deck below. There are three roof hatches which access the roof. The roof system appears to be in very good condition overall. It was observed that in some flat areas there is evidence of water damage and stains, it appears to be due to inefficient drainage due to a clogged drain. Corrective action recommendations consist of cleaning and unclogging roof drains.

Slow Slope Roof Covering - Single-Ply PVC

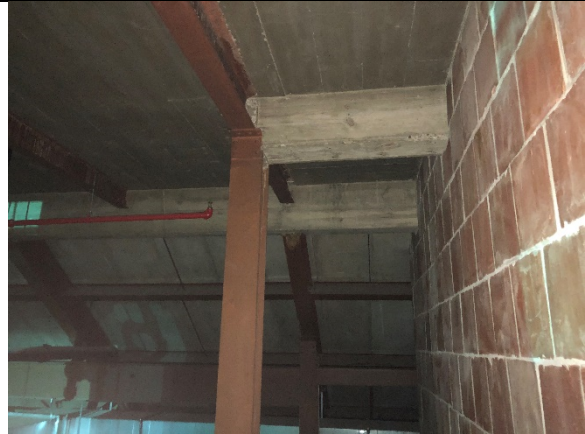
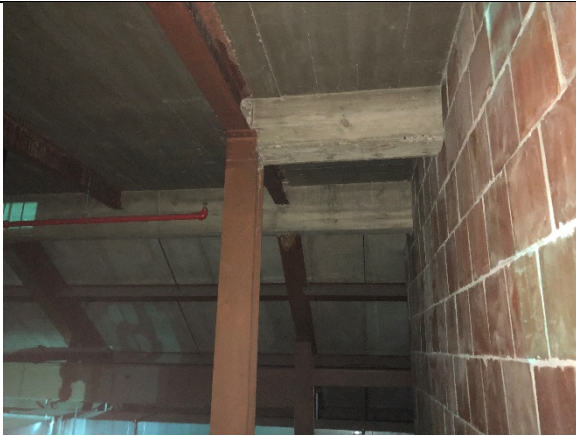
Figure S-7 Steel Framing in Attic with Minor Corrosion

*Figure S-7 Steel Framing in Attic with Minor Corrosion (RFR0-
BR1000-001)*

(RFRO-BR1000-001) In the roof framing, one beam was observed with localized corrosion to the top flange, likely the result of water. The corroded area should be cleaned and painted.

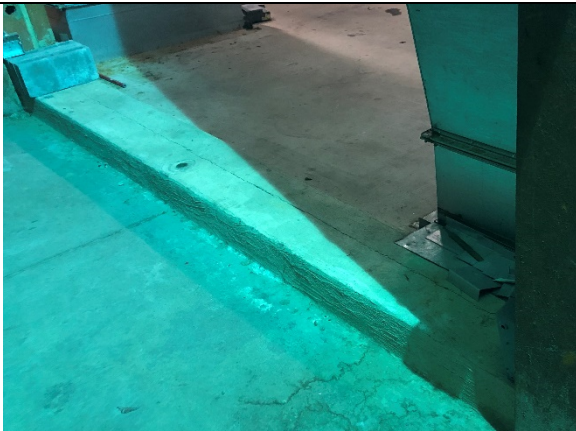
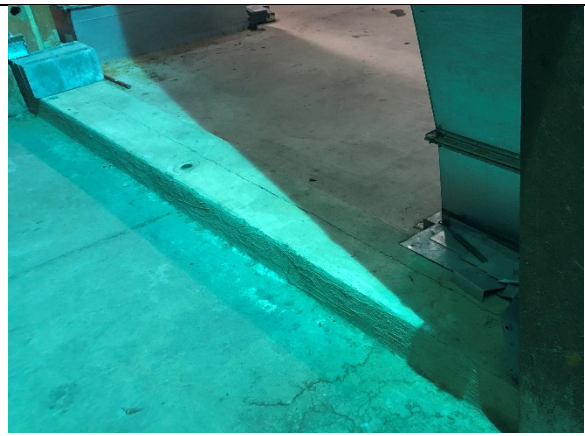
Figure S-9 Crack in Topping Slab Curb

Figure S- 9 Crack in Topping Slab Curb (FDSL-B04000-001)

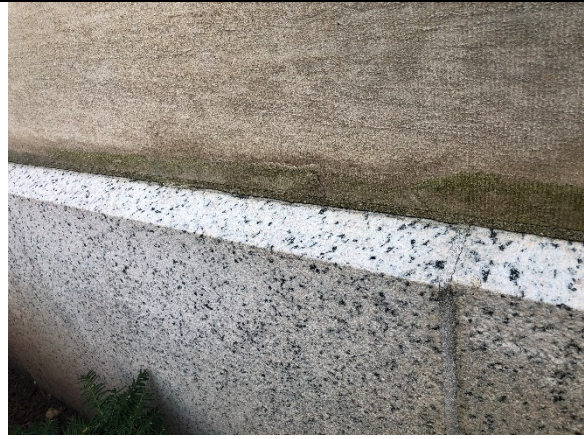
Figure S-12 Small Spall in Limestone at Base of Wall

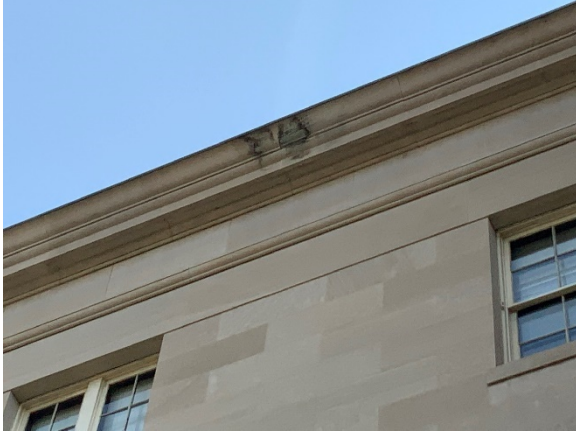
Figure S-13 Staining of Cornice Stone

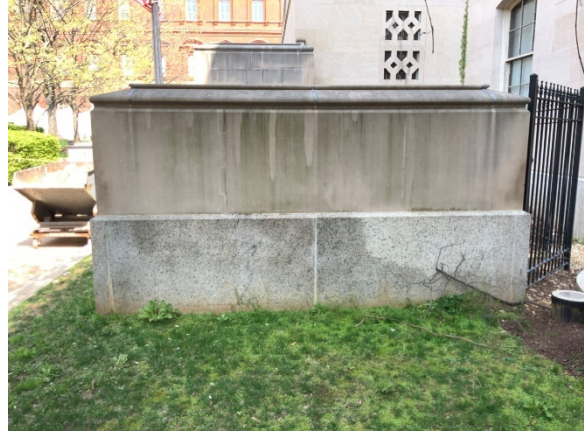
Figure S-14 Staining of Exterior Site Walls

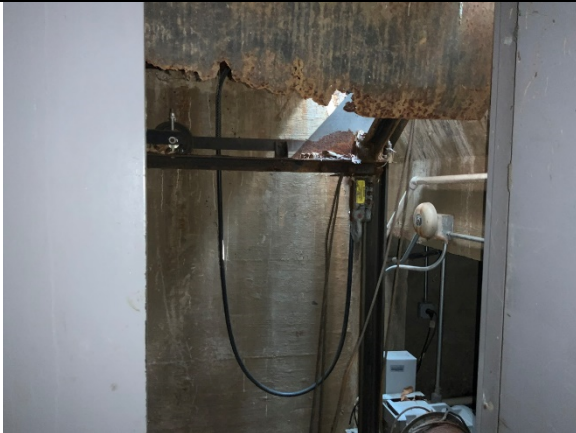
The reinforced concrete basement / areaway wall at the SE corner of the building at the loading dock equipment is corroding & spalling and will need repair or possibly replacement if the equipment is replaced. The equipment looks to be old and may need to be replaced depending on recommendations from the mechanical and architectural disciplines. If the equipment needs to be replaced, then it may be more efficient to remove and rebuild a portion of the existing wall as compared to repairing it. The existing concrete is spalling, and corroded reinforcing is exposed. Repairing the concrete is very possible and would require removing loose or degraded material, cleaning of rebar, applying corrosion inhibitor and patch concrete back to its original section.

Figure S-15 Loading Dock Lift Equipment

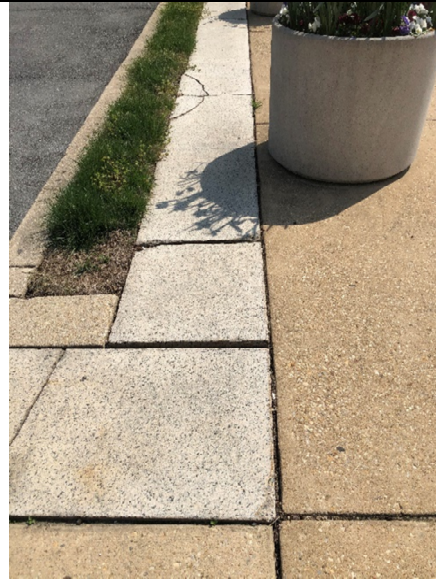
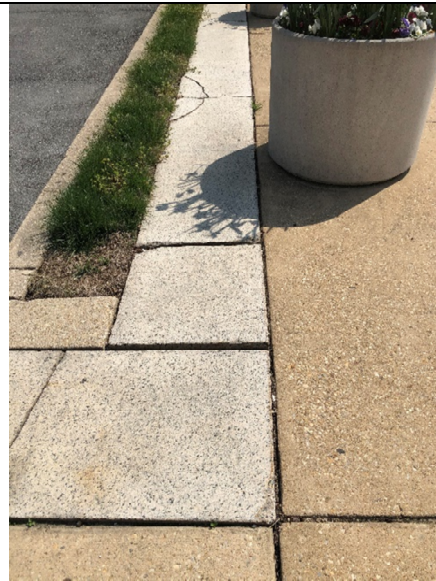
The east site paving and structures including sidewalks, parking lot paving and small site retaining walls all are showing signs of movement and deterioration. The sidewalk and paving are both cracking and settling locally, which do not necessarily prevent the use of these elements but to address these issues they will need to be replaced. The site retaining walls are relatively small and can be repaired by simply resetting the existing stones.

Figure S-19 Typical Settlement Cracking

*Figure S-19 Typical Settlement Cracking (PASU-B01000-001,
PASU-B01SNE-001, PASU-B01SSE-001) (CGCG-B01SNE-001,
CGCG-B01SSE-001, CUGU-B01000-001)*

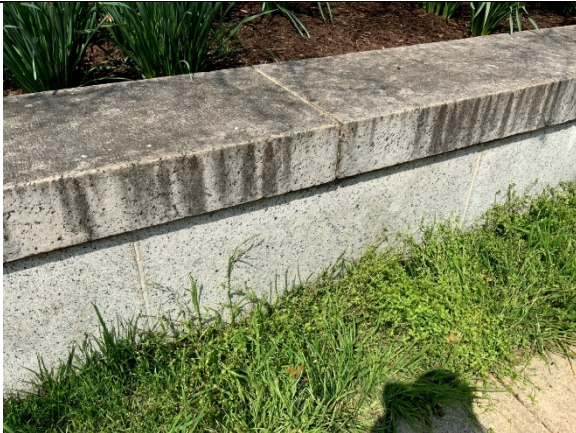
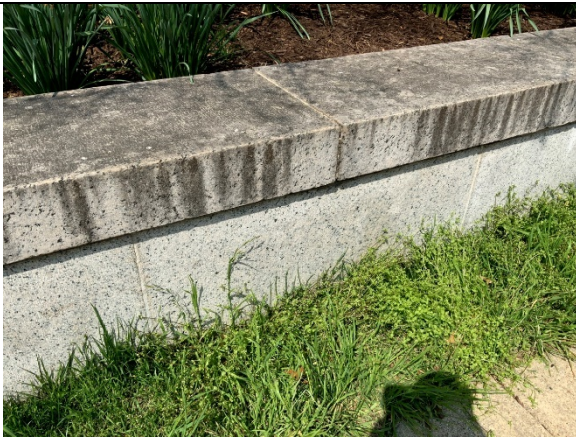
Figure S- 20 Site Retaining Wall

*Figure S- 20 Site Retaining Wall (RETW-B01SNE-001)
(CGCG-B01SNE-001, CGCG-B01SSE-001, CUGU-B01000-001)*

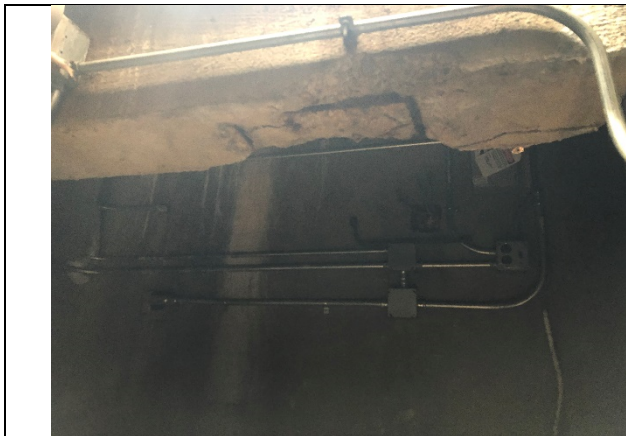
Figure S-16 Exposed Rebar in Beam at Loading Dock (BSWL-B00BSE-001)

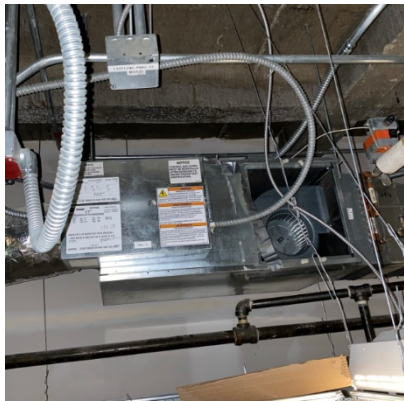
FPB missing filter

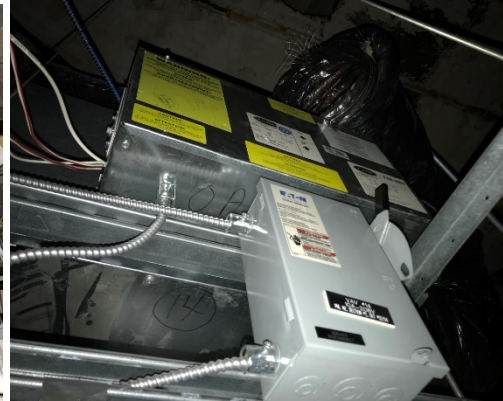
these FPBs do not have any supply air ductwork installed downstream of the box. The FPB is supplying air directly to the ceiling plenum. It is unclear where the thermostats are located for these boxes and how the FPB is being controlled. It was observed at the time of the survey that these FPBs were operational and the FPB secondary recirculation fan was running.

FPB primary air duct disconnected

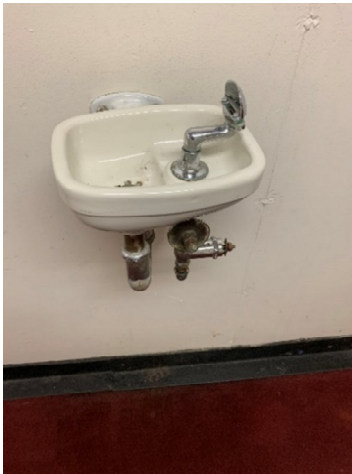
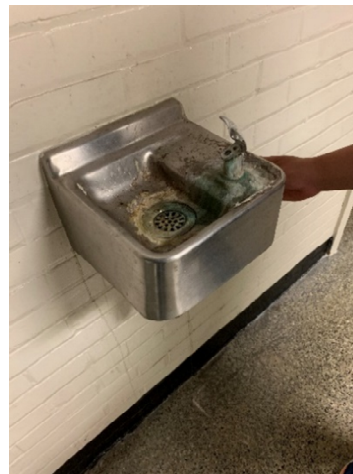
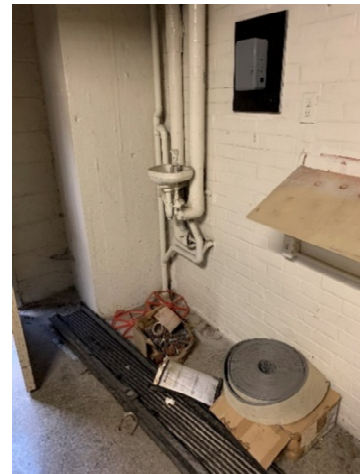
Basement has multiple drinking fountains that are out of service

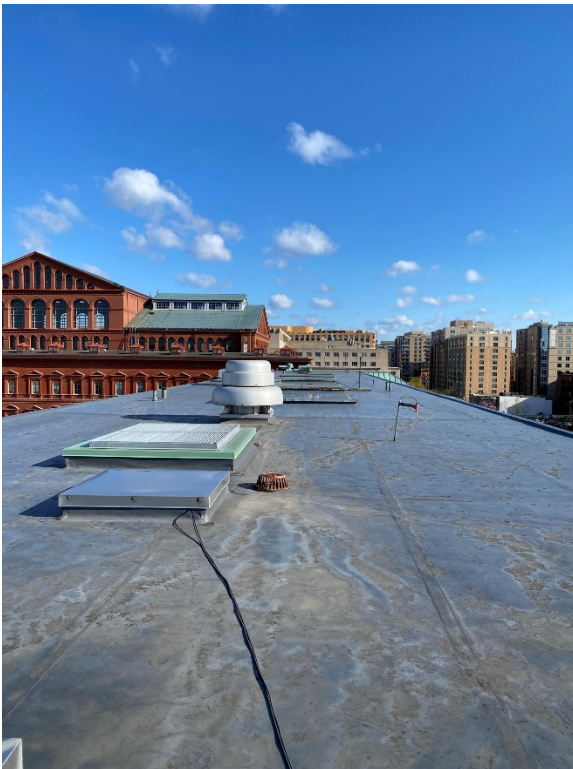
No existing lightning protection system was observed during the surveys.

No lightning protection system

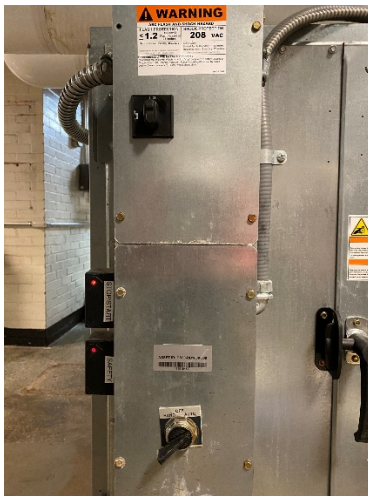
1. Rust and water damage was found on some equipment (ie. a disconnect switch). It is hazardous to have water within an equipment's dedicated working space.
2. Many panelboards are nearing full capacity and lack spares and spaces for future use.
3. At least one panelboard had a damaged door.
4. Some panelboards had a malfunctioning or missing latch/lock assembly (PNLO-BB1000-002)

Rust & water damage

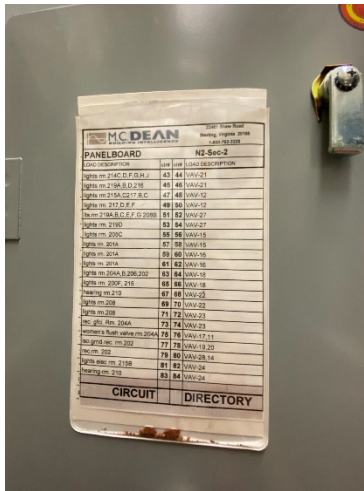
Typ panelboard near capacity

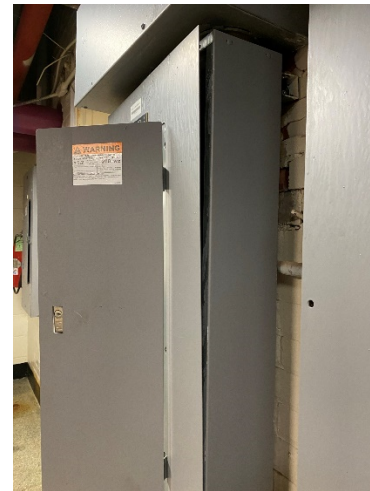
Panelboard with damaged door

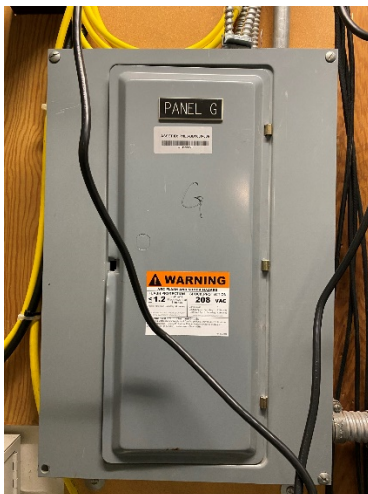
Panelboard with missing latch/lock

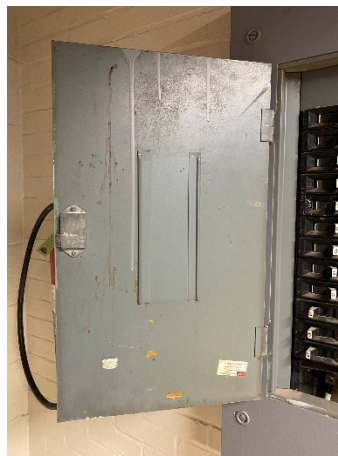
Missing circuit index card

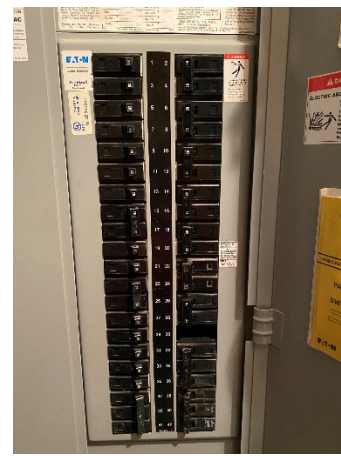
Missing blank covers over spares

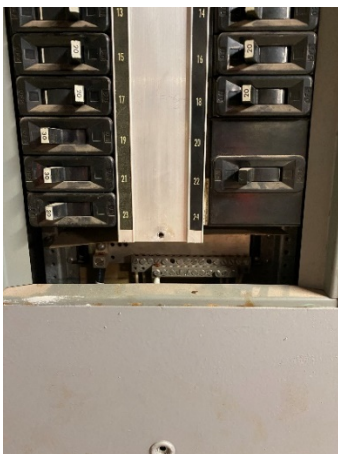
Missing interior face

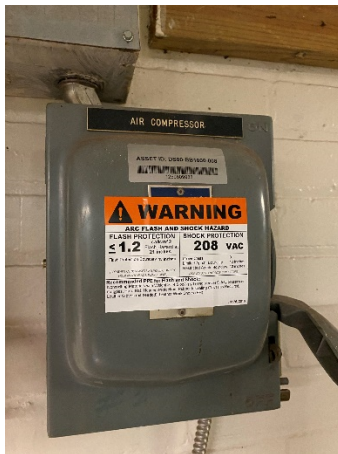
Disconnect Switch with nameplate data covered

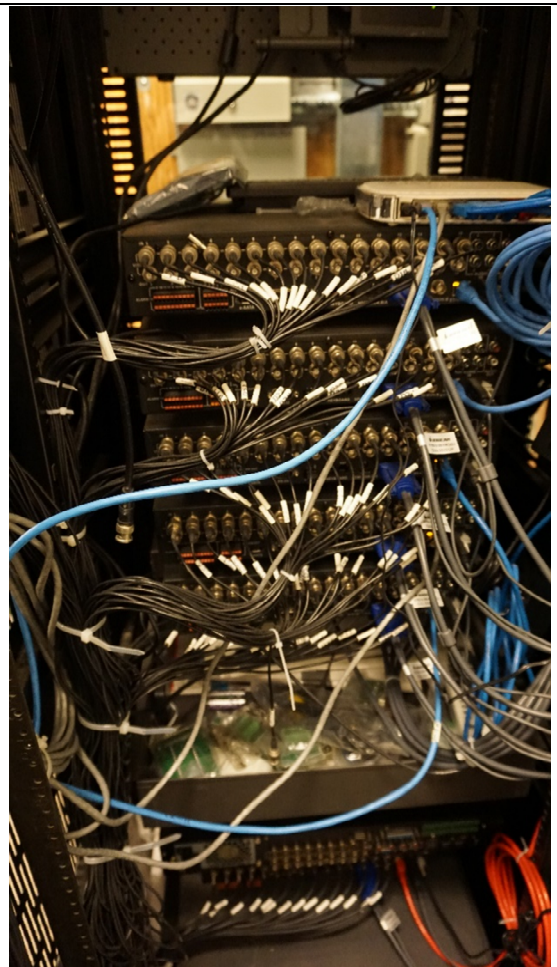
Analog Video Chassis

Recommendation: Replace the entire video management system with IP based digital video system. Use of analytics to improve forensic, recording methods, and extend retention.

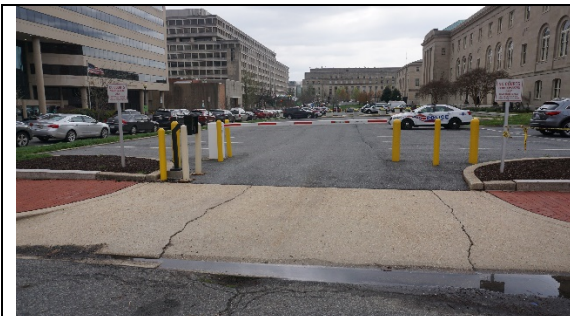
8-10 years old. While they appear to be under maintenance program, the systems will likely require replacement in the next 3-5 years. Replacement may be partial of the typical wear and tear components (gates and traffic lights).

Vehicle Entry Control System, North

Recommendation: Anticipate replacement of gate controllers within the next 3-5 years. The remaining components (traffic lights, intercom, and card reader) will need to be replaced within 5-7 years.

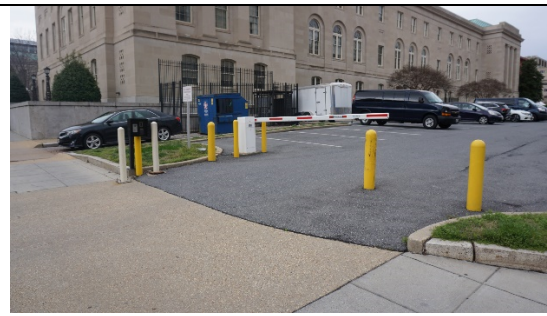
Vehicle Entry Control System, South
