District of Columbia Courts

BUILDING ASSESSMENT REPORT

PRELIMINARY REPORT (BUILDING B ONLY)

510 4th Street, NW

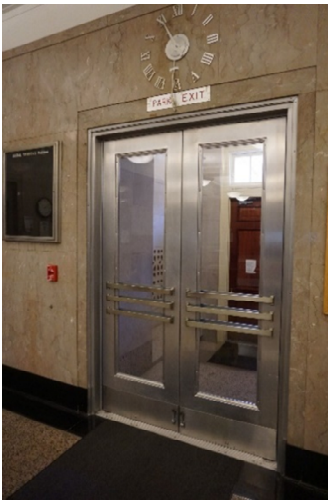
Glazed Metal Frame Doors

More specifically, all (3) public stairs require guardrails on both sides that are a minimum 42" high. The existing handrails do not extend 12" from the bottom tread, as required by code, but are within the 30-42-inch height. And the historic glazed metal frame doors at the ground level main entrances do not adhere to the minimum width required for egress.

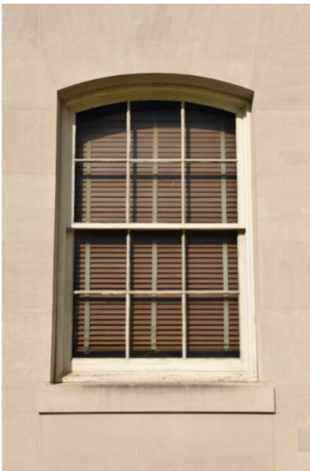
Typical Wood Framed Double-Hung Window

All building elevations include historical custom wood framed double-hung windows with insulated glass and an extra layer of glazing in the interior which was installed in recent years for extra thermal performance. All windows throughout the building are fixed. The main deficiency noticed at the windows is the condition of the wood frames, especially the window wood sills. The window wood frames seem to have deteriorated and are in critical condition due to weathering. The Architecture building enclosure team recommends repair and refinish all window framing and replace as needed, beginning at the south elevation which is in the most critical condition. All window exterior glazing must be cleaned due to the presence of dust and debris.

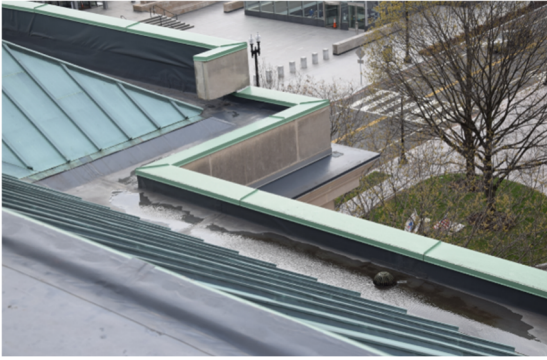
Standing Water by drain location

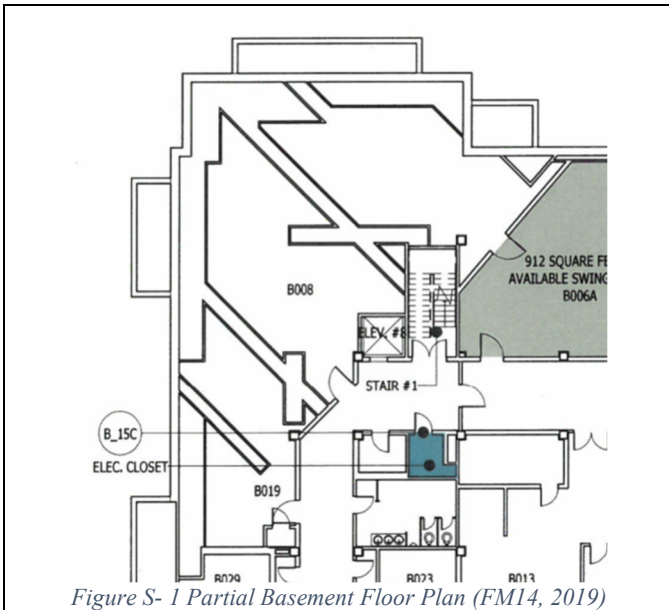
Figure S- 1 Partial Basement Floor Plan (FM14, 2019)

There was one unusual foundation item that was observed and is still being investigated, which are several large grade beams occupying the space between the basement level and the first floor in the SW corner (see Figure S- 1 and Figure S- 2). They are oriented at an angle to the building in the SW direction and appear to transfer column loads to foundation avoiding a bearing condition, but the specific reason for their being there is not known. It is unclear if they are original to the building or if they were installed at some subsequent renovation, but they do appear to be an existing condition in the *Interior Improvements to DC Superior Courts Building 'B'* renovation project. They also appear to extend outside the building because there is a corresponding saw-cut joint in the slab on grade on the exterior sidewalk (see Figure S- 3). There is no sign that grade beam support configuration is causing damage or is deteriorating. Reasons to investigate them further would be to (a) understand them better to make sure any adjacent construction doesn't affect them as they extend beyond the footprint of the building and (b) determine if there is reserve capacity in the system.

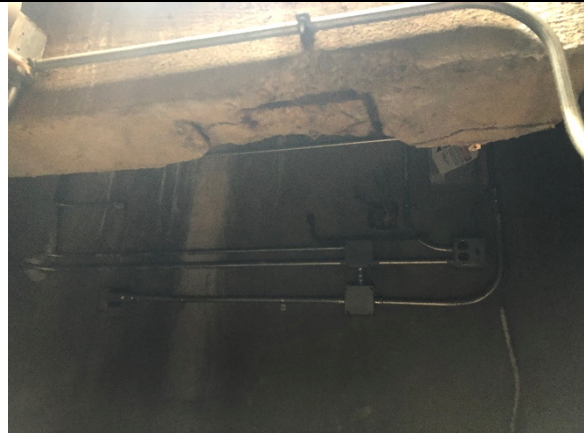
Figure S-16 Exposed Rebar in Beam at Loading Dock

The reinforced concrete basement / areaway wall at the SE corner of the building at the loading dock equipment is corroding & spalling and will need repair or possibly replacement if the equipment is replaced. The equipment looks to be old and may need to be replaced depending on recommendations from the mechanical and architectural disciplines. If the equipment needs to be replaced, then it may be more efficient to remove and rebuild a portion of the existing wall as compared to repairing it. The existing concrete is spalling, and corroded reinforcing is exposed. Repairing the concrete is very possible and would require removing loose or degraded material, cleaning of rebar, applying corrosion inhibitor and patch concrete back to its original section.

The basement wall is a reinforced concrete wall typically with a few areaways around the building. The areaway that is the loading dock lift/elevator going from grade down to the basement level was showing signs of deterioration (see Figure S-15). The concrete is spalling and some of the lintel beam reinforcing is exposed and corroding (see Figure S-16). The loading dock lift mechanism and embedded steel connections to the concrete walls are corroding. If a new lift is installed it should be assumed that there will be a significant portion of the concrete areaway wall that is rebuilt.

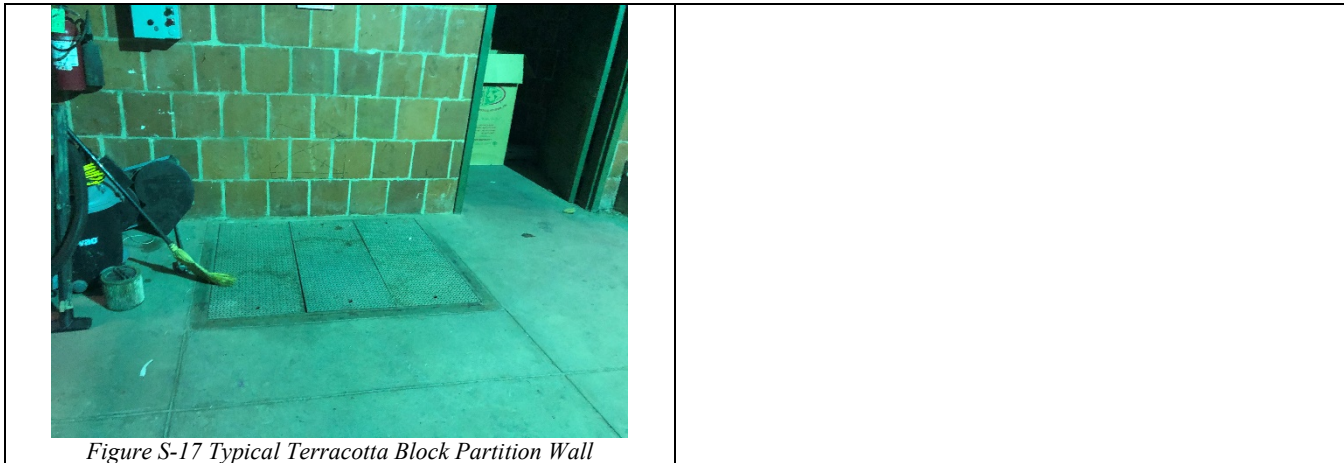
Figure S-17 Typical Terracotta Block Partition Wall

Interior partition walls were observed to typically be hollow / unreinforced terracotta blocks (see Figure S-17). In some places where renovations have been done the terracotta was replaced with CMU. There was no specific issues observed with the terracotta blocks. Based on experience it should be noted that these partition walls have limited capacity to hang heavy objects and span over wall openings. Future modifications should consider how these walls will need to be changed as it may require replacement of the wall.

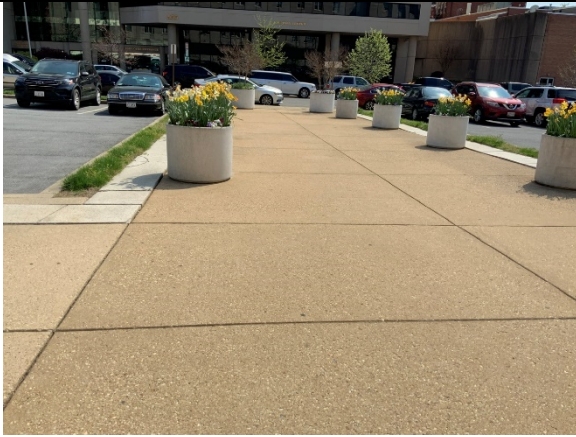
Figure S- 18 Sidewalk Paving On East Side

The east site paving and structures including sidewalks, parking lot paving and small site retaining walls all are showing signs of movement and deterioration. The sidewalk and paving are both cracking and settling locally, which do not necessarily prevent the use of these elements but to address these issues they will need to be replaced. The site retaining walls are relatively small and can be repaired by simply resetting the existing stones.

The exterior paving and site walls on the west side of the building facing the park were all in good condition and appeared to have been replaced recently. The exterior paving on the east side of the building is the parking lot and sidewalks that serve it including the center walkway from the main entrance that has granite blocks inset into the sidewalk paving (see Figure S-18). The sidewalks are typically concrete slab on grade with an exposed aggregate finish and the parking area is asphalt paving. Both the sidewalk areas and the parking lot areas are all showing signs of local pockets of settlement as evidenced by the varying elevation and cracking typical throughout (see Figure S-19). Both elements are still functional and will likely be for several more years but in the long term they will need to be replaced to fully resolve the settlement issues. A new installation of paving will need to investigate and appropriately provide suitable bearing to prevent settlement. The small site retaining walls on the east side facing the parking lot are functional but have significant grout loss between stones and some stones are displaced (see Figure S-20). To repair this wall the existing stones can simply be reset.

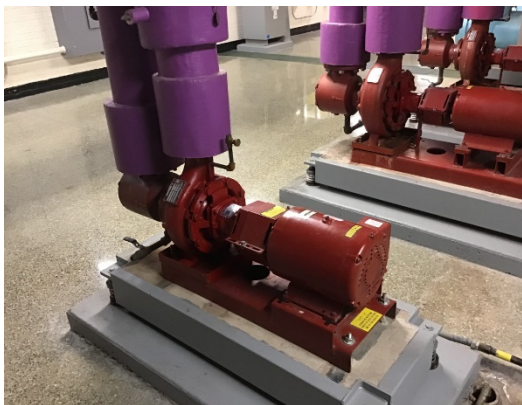
HHWP-BB1000-001

All heating hot water pumps are Armstrong, model 4030, end suction base-mounted type installed on vibration isolation pads. It is unknown when the pumps were installed, but it appears the pumps are in good working condition and regular pump maintenance should be performed.

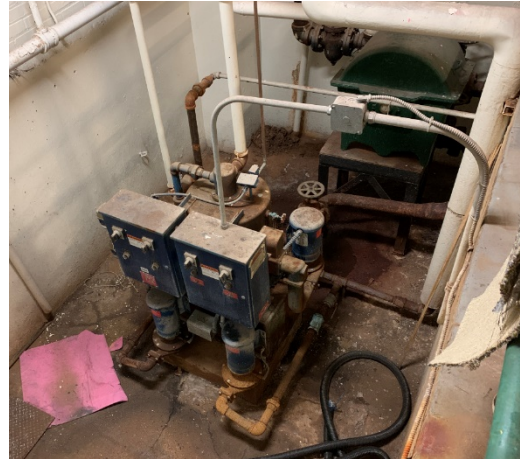
STCP-BB1000-001

The steam condensate is collected and brought to a duplex steam condensate pump package located in a pit near the steam equipment (STCP-BB1000-001). From discussions with the building engineer, the steam condensate is pumped and drained to another location in the building and dumped down the drain. It is unclear if the steam condensate is cooled below 140°F prior to dumping down the drain to comply with current building codes. The duplex steam condensate pump package appears to be badly damaged and has visible corrosion and leaks.

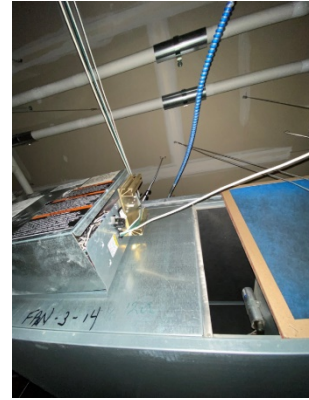
FPB filter dislodged

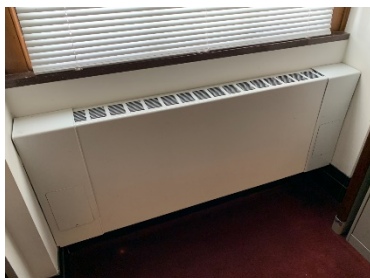
Typical FTR

and closes in a mechanical process that is responsive to temperature. The TRVs are not modulated or monitored by the building automation system. This is an outdated method of temperature control and is not used in modern commercial buildings. TRVs do not provide accurate temperature control when compared with modern direct digital control valves.

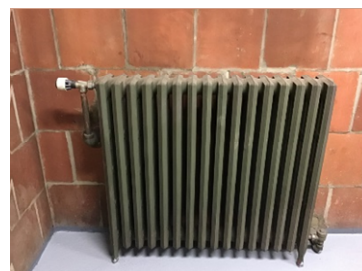
Courthouse FTR

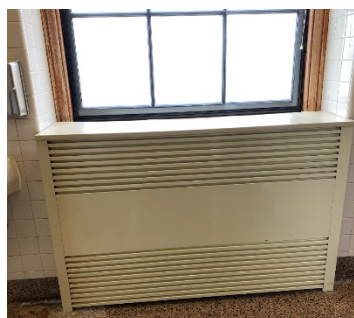
Building B perimeter heating is provided by fin tube radiators (FTRs) installed along the perimeter of each space. Most FTRs are hot water radiators that were installed during the buildings 2003 renovation. However, there are a handful of steam radiators used in the bathrooms, stairwells, and penthouse spaces that are original to the building. All fin tubes are approaching the end of their useful life and should be replaced within 10 years. The steam radiators should be replaced with hot water FTRs.

Steam FTR

1. Replace all original steam radiators (approximately 8 total) with new hot water fin tube radiators. Provide new hot water piping to the fin tube radiators.

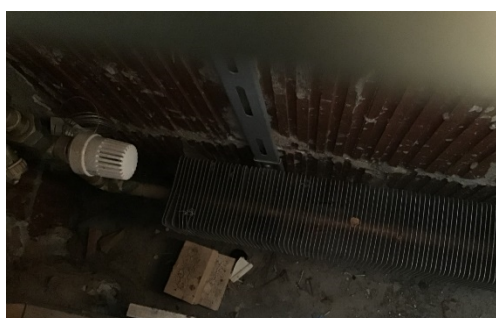
Restroom Steam FTR

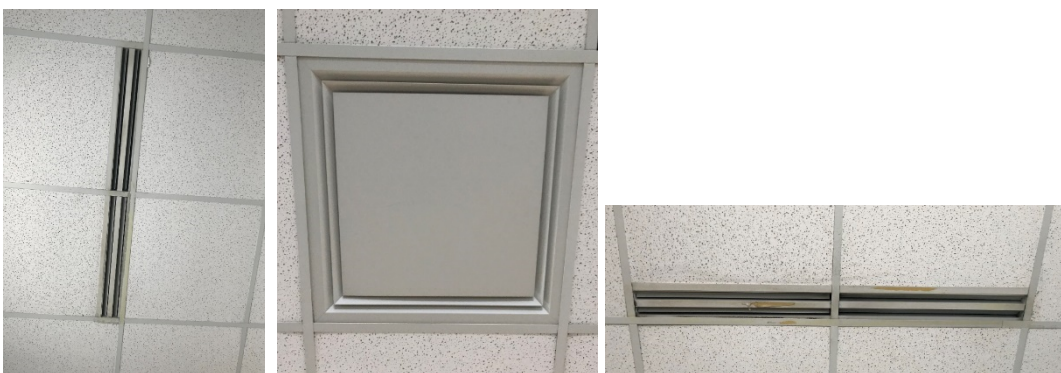
Building B is served by a variety of types of ceiling grilles, registers, and diffusers. In general, perimeter office areas are served by linear diffusers above the windows, while interior spaces are served by 2'x2' lay-in ceiling grid diffusers. Some visual corrosion and paint chipping can be seen on the diffusers. It is estimated that 25% of the building's diffusers are in poor condition. In addition, dust and debris can be seen on many diffusers.

Linear Diffuser

Square Plaque Diffuser

9. Clean all grilles, registers, diffusers so they are free of dust and debris. Replace all grilles,

registers, and diffusers showing damage or corrosion (approximately 25%).

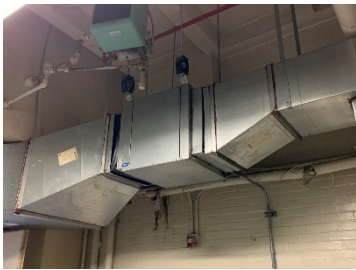
The basement level consists of 4 additional exhaust fans. EF00-BB1000-001 serves as the refrigerant exhaust and chiller ventilation fan. The refrigerant exhaust fan was operating at the time of the survey and appears to be in good working condition. EF00-BB1000-003 serves as generator exhaust fan. EF00-BB1000-003 was operating at the time of the survey. The exhaust fan was loosely mounted and showed excessive vibration. EF00-BB1000-002 serves as an exhaust in an IT room for cooling purposes. The fan was not operational at the time of the survey and it appears that IT equipment could be overheating. EF00-BB1000-004 provides toilet exhaust for two restrooms in the basement. EF00-BB1000-004 is located in an adjacent IT closet. In addition, it appears EF00-BB1000-004 is exhaust toilet exhaust into the ceiling plenum of the basement. This does not comply with current building code.

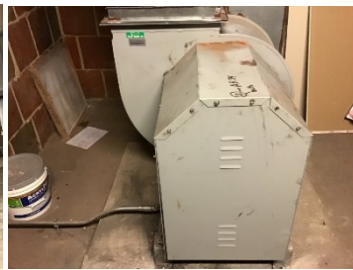
The majority of the Building B exhaust air occurs in the penthouse level. Two Greenheck centrifugal exhaust fans (EF00-BPH-001 & 002), provide exhaust to the north and south sides of the building. EF00-BPH00-001 serves the north wing and EF00-BPH000-001 serves the south wing of the building. Each exhaust fan in the penthouse exhausts air through an air-to-air energy recovery unit to pre-condition outside air prior to exhausting the air out of the building. The exhaust fans are constant volume and do not have VFDs installed.

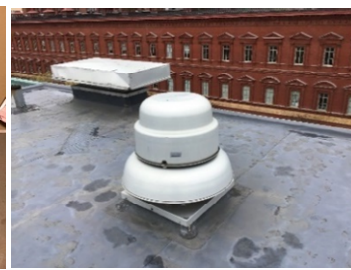
EF00-BR1000-001

There are three additional Cook, ACE, down blast mushroom exhaust fans located on the south, central, and north portion of the roof (EF00-BR1000-001, 002, & 003). These exhaust fans appear to be original to the building and the region they serve is unknown. The exhaust fans located on the roof appear to be approaching the end of their useful life. They had visual corrosion and the exhaust fans were not operating at the time of the survey.

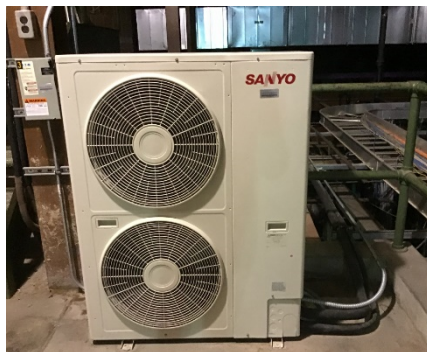
Building B IT, electrical, and elevator machine rooms are cooled with split system VRF units. Multiple manufacturers are used throughout the building including, Sanyo, Goodman, and Daikin. In general, the split systems are all in working condition, but are nearing the end of their useful life. The outdoor condensing units are scattered outdoors around the building on ground level. However, there are also four outdoor condensing units located inside of the penthouse.

Outdoor Condensing Unit

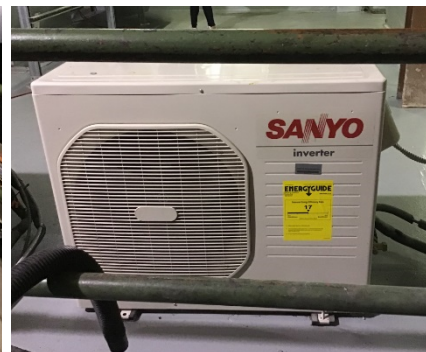
Outdoor Condensing Unit

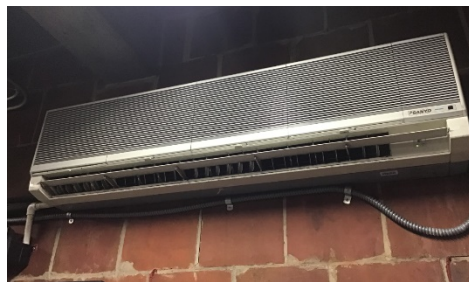
Indoor Unit

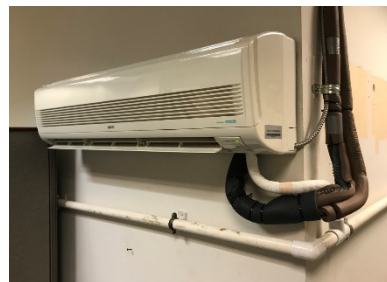
Indoor Unit

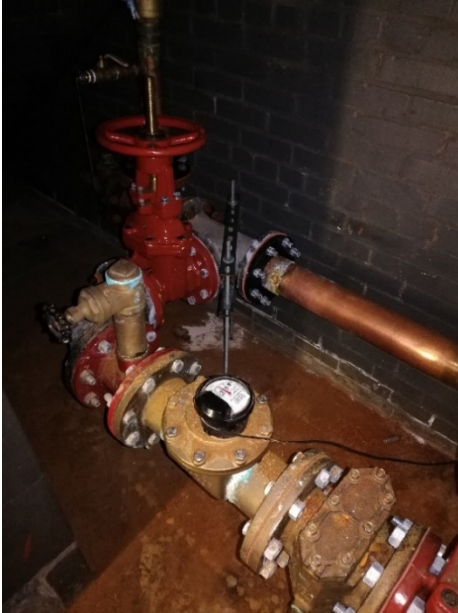
DWM0-BB1000-001

Domestic water for building B connected from an 8 inch water main at F ST. 4 inch domestic water enters the building in a small room under stair C. Building B has multiple isolation valves, a by pass and a water meter (DWM0-BB1000-001). The water service is not protected by a main backflow preventer.

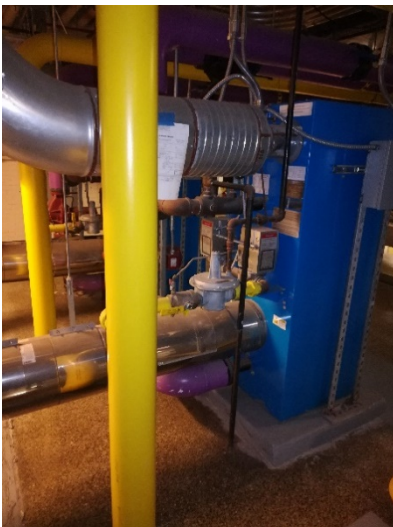
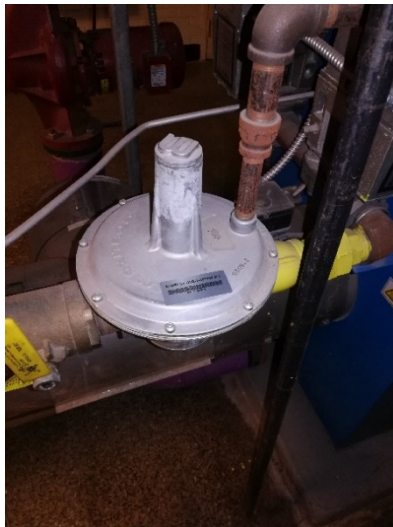
It appears on the existing drawings a natural gas service that enters the building plan east of building B. Evidence shows that the gas service was disconnected, and the gas meter and regulator were removed from the site. However existing gas piping remains and abandoned in place throughout the basement and to the boilers. Boilers are currently operating with steam and not gas.

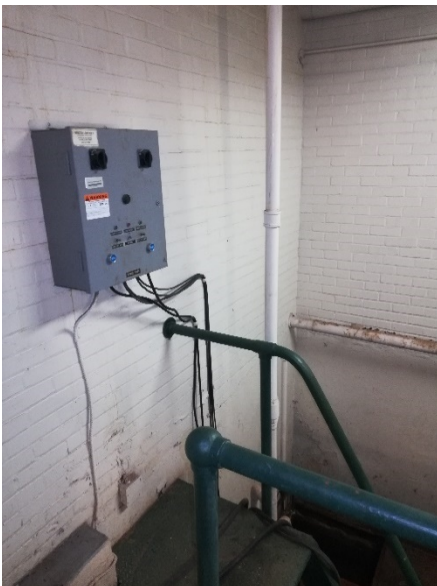
SP00-BB1000-002

B1 level has two sump pumps for underground water system. One is located in mechanical room #B42 pit (SP00-BB1000-002). Pumps seem to be an original piece of equipment and passed the end of the life cycle.

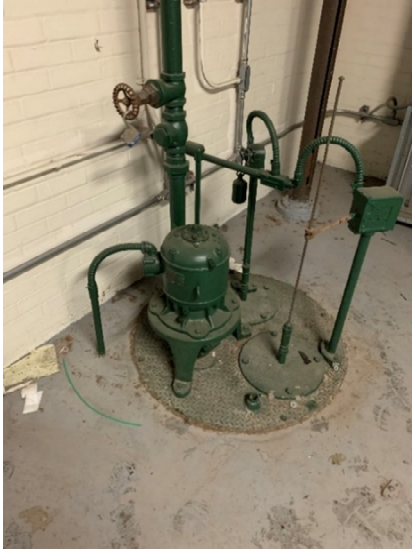
SP00-BB1000-001

Second sump pump (SP00-BB1000-001) is located in chillers room #B18. The pump seems to

be an original piece of equipment and passed the end of the life cycle.

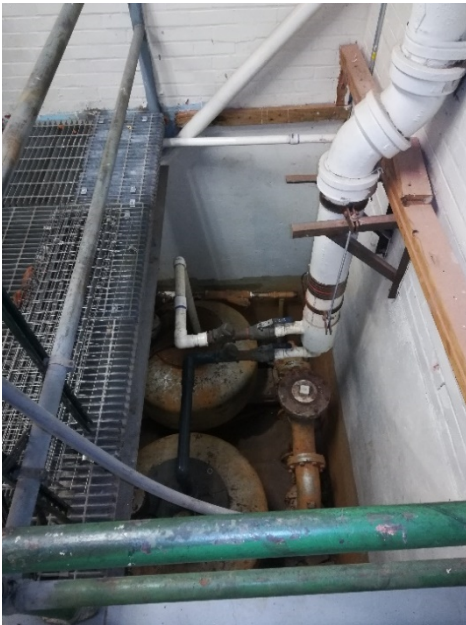
SE00-BB1000-001

Building B has a main sewer located along the west side of the building, the building has numerous wet stack (Sanitary & Vent) throughout each floor. The building main sanitary is exiting the building below first floor slab. All restrooms, locker rooms and floor drains on the basement level is discharging by sewage ejector pumps. There are two ejector pumps on the basement level. Similar to the storm water ejectors, these pumps appear to be original to the building and have exceeded their expected life cycle. Facilities staff have reported pump failures that have resulted in basement flooding.

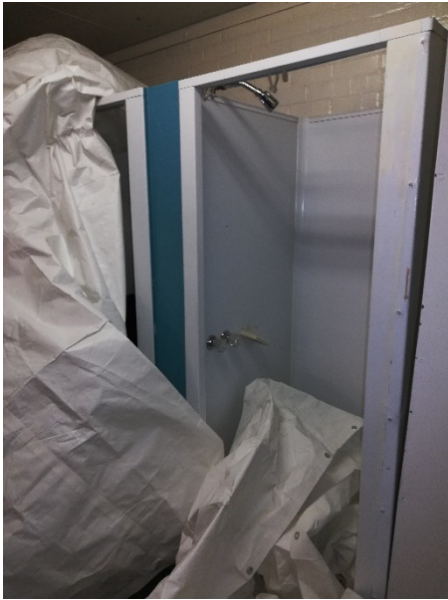
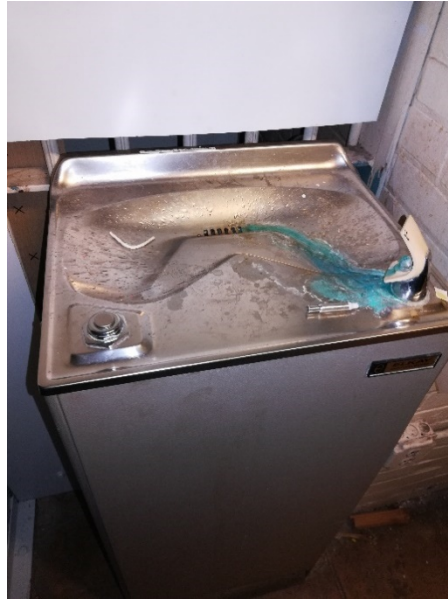
Drinking FOUNTAINS:

Basement has multiple drinking fountains that are out of service

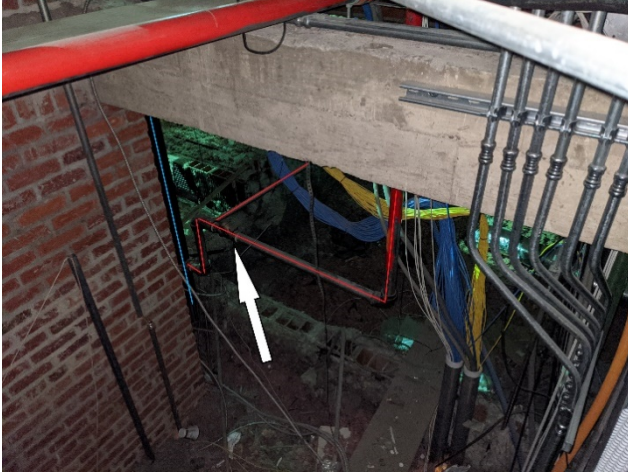
Indirect waste drains, specifically from a fire protection dry valve, are deficient as they

connect directly to a vent piping. Open end drains shall be provided with deep seal traps, vents, and backwater valves, as required per the Plumbing Code, in order to receive indirect waste from fire protection and HVAC.

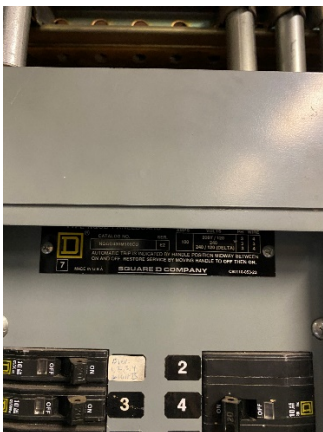
7. Externally illuminated exit signs do not appear to meet NFPA 7.10.6.3 illumination requirements.
8. Many panelboards were found to be missing the following labels or information. Identification information is required per NEC articles 110.21 Markings, 408.4 Field Identification Required and 408.58 Panelboard Marking. Examples listed below:

- a. Front cover identification labels
 - b. Branch circuit number identifiers.
 - c. Completed circuit index cards with room identifiers
9. Many panelboards were missing blank covers over spares/spaces. Unused openings are required to be closed per NEC articles 110.12 and 408.7.

Missing front cover id label

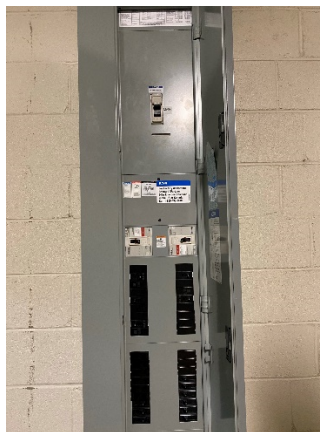
Missing number identifiers

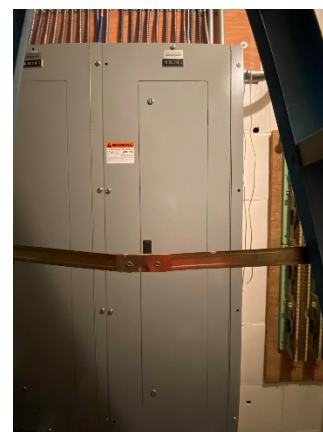
The north and south electrical closets on Levels 1, 2, and 3 are all identical. The main switchboard feeds a double section panelboard in each electrical closet, which then feeds a single section panelboard. Equipment and working clearances were often found to be obstructed within the electrical closets. The following table summarizes the stacked electrical closet equipment.

Obstructed working space

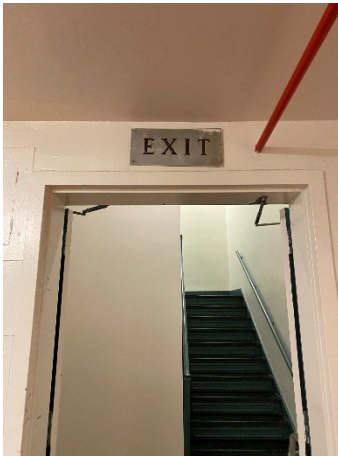
Unlit Exit Sign

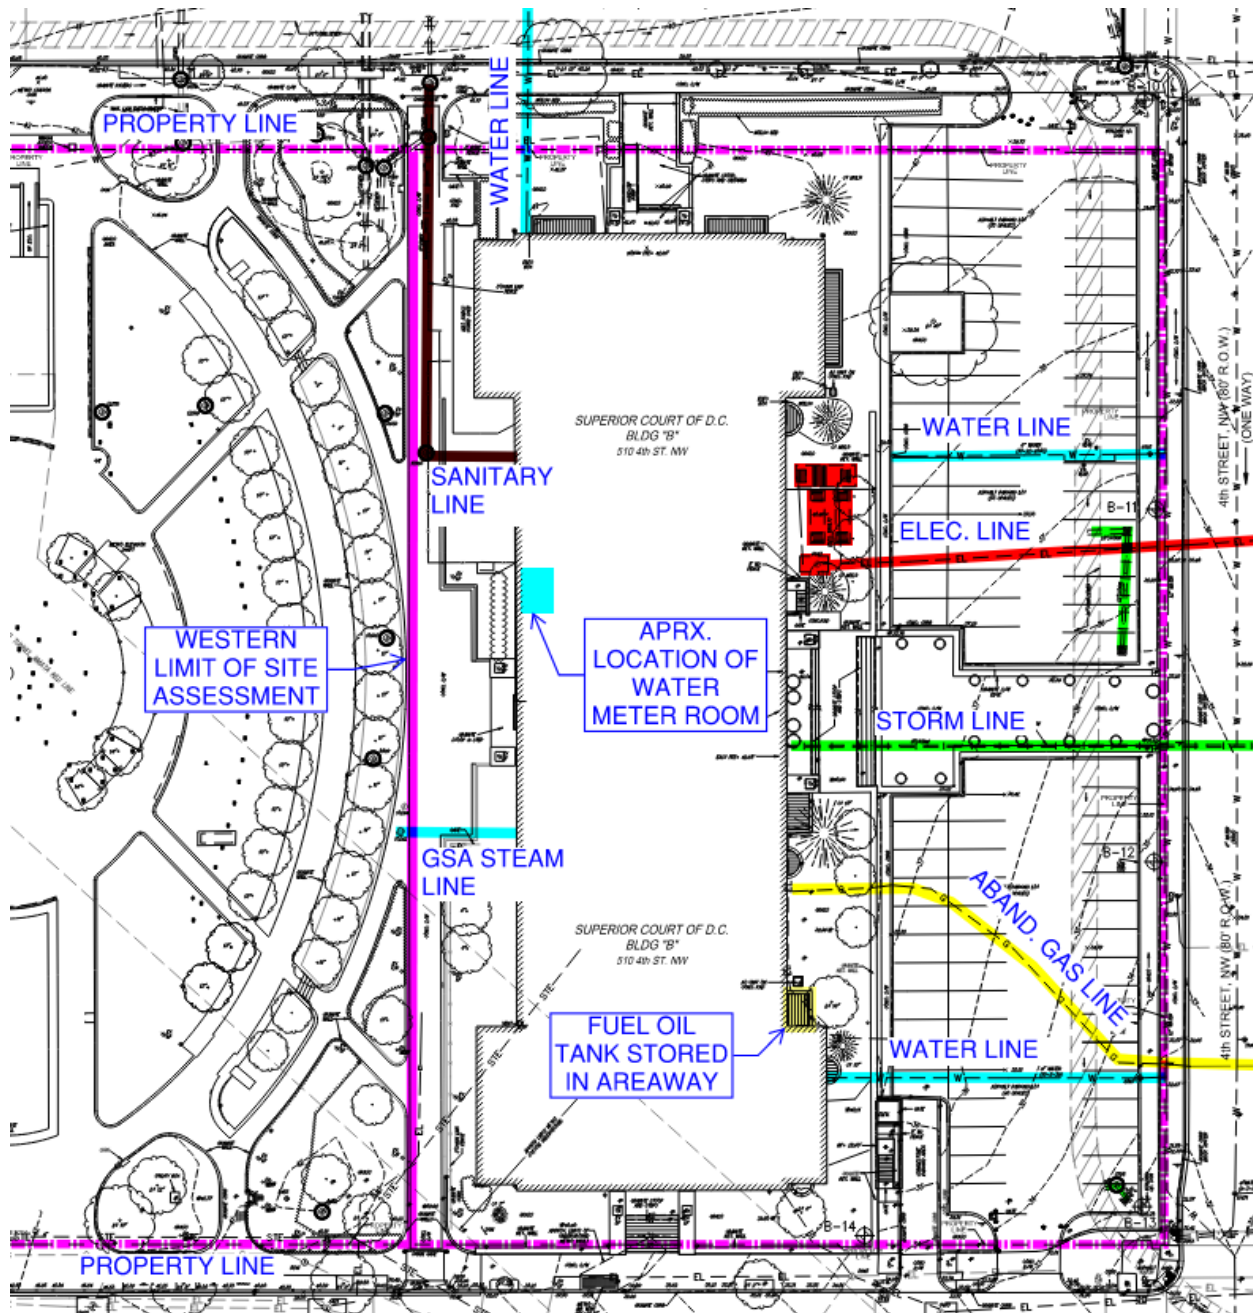
Figure 1 - Building B Site Utility Services

According to utility records and structures observed in the field, Building B is served by three (3) water supply lines, one (1) sanitary line, one (1) storm water line, one (1) electrical service line, and one (1) steam service line. Records also indicate a natural gas line was once in operation but has since been abandoned. The point of service for telecommunications could not be verified. Please refer to the I.T. section of this report for additional information. Finally, a fuel oil storage tank was observed installed within an areaway to support back-up generator functions. Please refer to **Figure 1 – Building B Utilities** below for approximate layout and locations of these utility systems.

A manhole cover stamped with STEAM was located on the West side of the building. According to interviews with Building Engineering personnel Building B is served by GSA Steam from the western side of the structure. Although its location was restricted from inspection at the time, Building Engineering indicated the meter for the steam service was located in a room along the western edge of the building. This aligns with the observed STEAM manhole cover. Unless specific agreements are in place, typically GSA owns and maintains service and structures up to the meter. DC Courts is then responsible for all equipment after the meter.

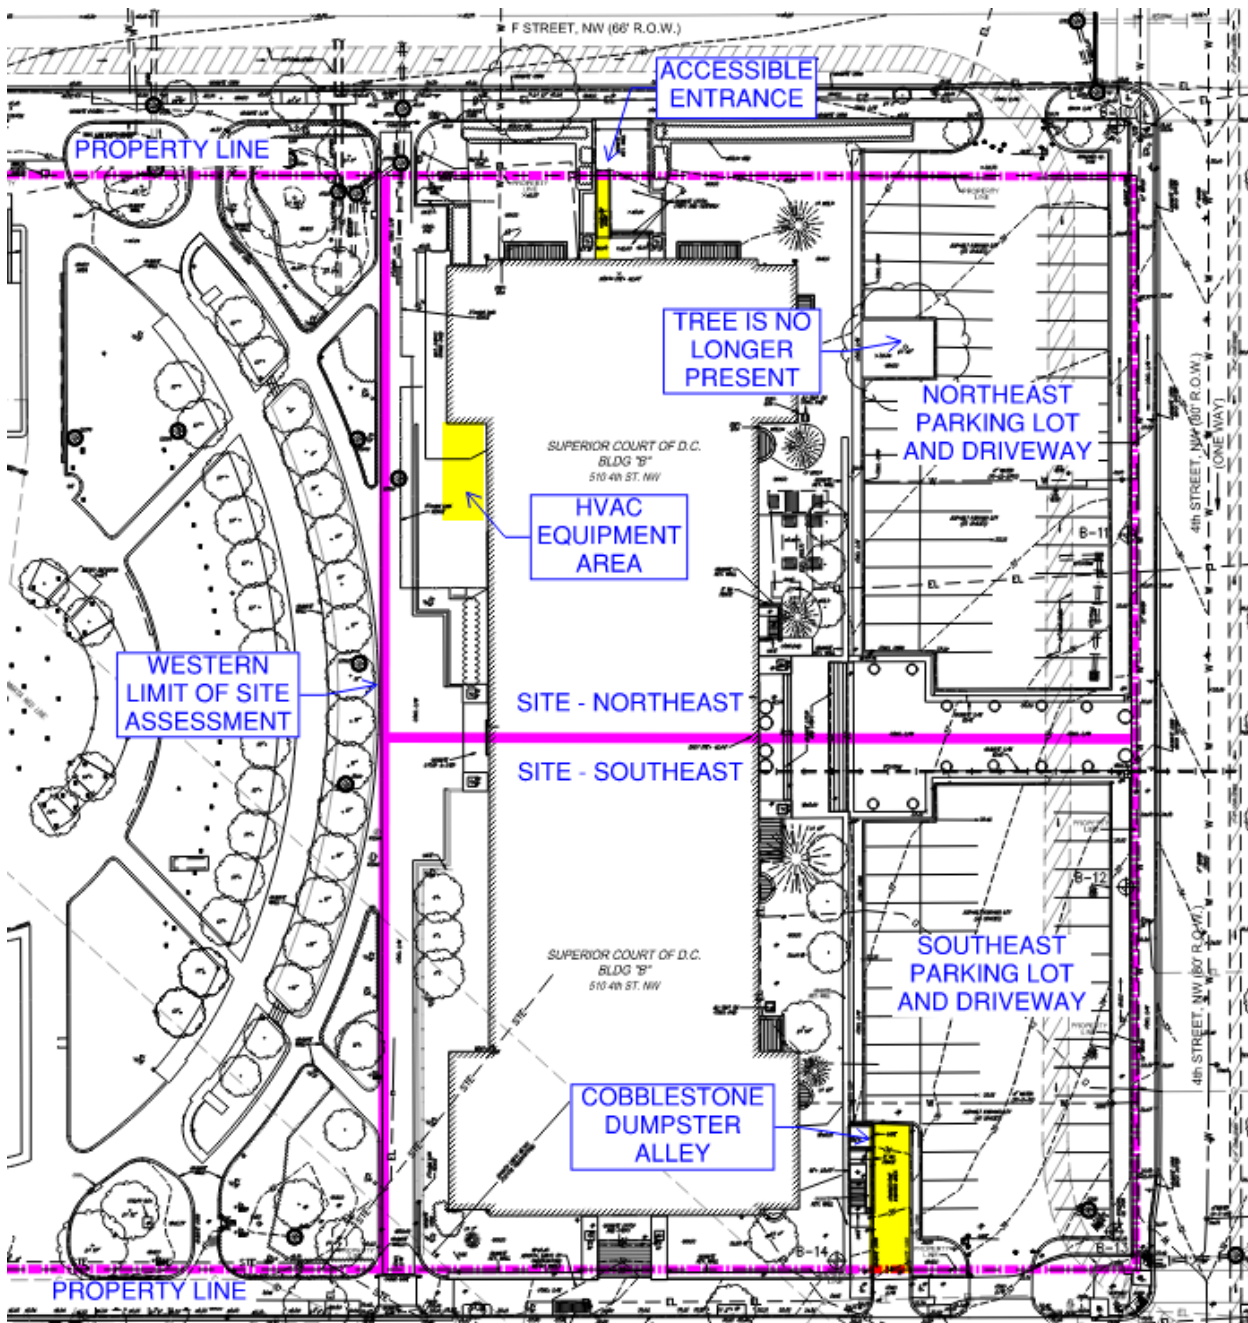
Figure 2 - Building B Civil Site Elements

Generally, grading around the site all appears to be sufficient to provide positive drainage away from the building. There was very little evidence of negative slope towards the building, with only small, isolated areas of subsidence that could be easily backfilled and compacted.

The private service drive along the western side of Building B, connecting E & F Streets appears to have been constructed at a later time than the rest of the site. Considering the concrete pavement, granite paver borders, and limestone curbing all seem to match the materials used in the National Law Enforcement Officers' Memorial, it may have been constructed at the same time. The assessment assumes the DC Courts responsibility ends at the western edge of this service drive.
